# **2014 Riparian Health Inventory Project (Year 4): Westslope Cutthroat Trout Priority Streams**

*A Summary of the Riparian Health Status and Habitat Improvement Needs for  
14 Priority Westslope Cutthroat Trout Sites in the South Eastern Slopes of Alberta*

Alberta Riparian Habitat Management Society (Cows and Fish)  
Report No. 044

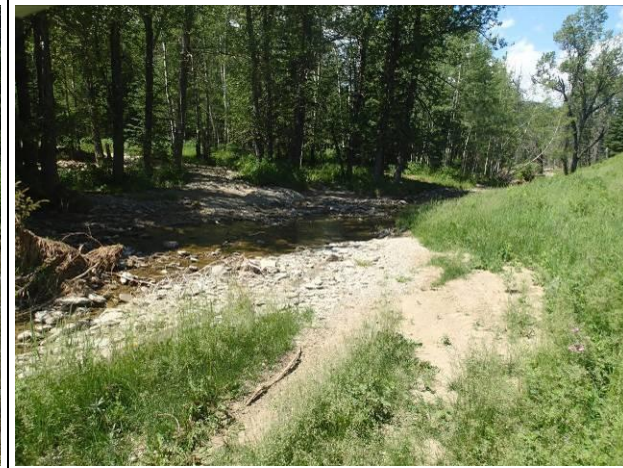
**Photo c:** An Aspen / Timothy-Kentucky bluegrass community occurs along the upstream reach of Trout Creek (TRO1). Human-caused ecosystem modifications (e.g. logging roads, livestock grazing, recreation use, etc.) have contributed to an influx of non-native disturbance-caused grasses and forbs in the understory. (Photographer: A. Sarrazin, Catalogue No: RHIP01TRO020)

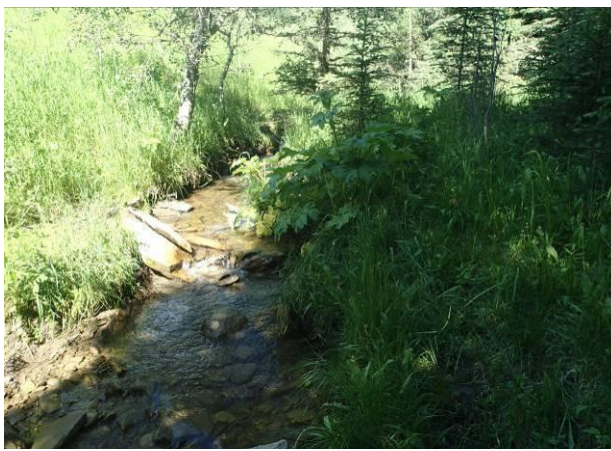
**Photo e:** A modified Kentucky Bluegrass - Timothy community along Sharples Creek in SHA3. Historic conversion of adjacent lands to seeded pasture has contributed to proliferation of non-native grasses in this watershed. (Photographer: A. Sarrazin, Catalogue No: RHIP03SHA005)

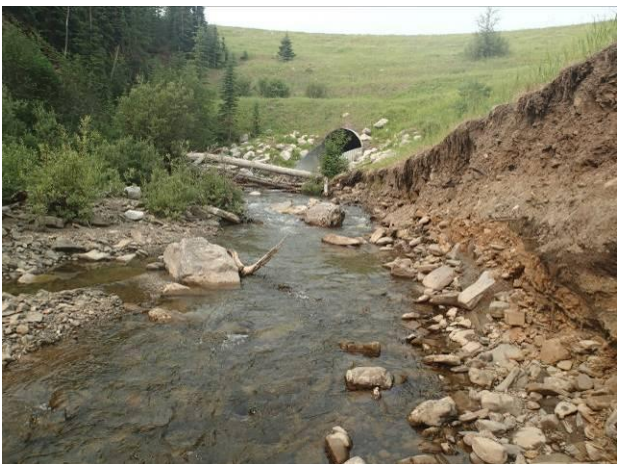
- **Non-native disturbance-caused plants have more than 50% cover in BVR42 and TRO1; 25% to 50% cover in GRE1, DUT1 and GOL2; and 5% to 25% cover in SHA3 and STA1.** Disturbance-caused plants in these sites are associated with historic and recent human and natural-caused disturbance factors, mainly recreational use impacts, livestock grazing and access roads. The remainder of the project sites have less than 5% disturbance-caused plants, localized to road ditches or access trails (e.g. VIC1 – **Photo g**, page 18).

**Photo g:** Disturbance-caused plant communities are concentrated in many sites to disturbed road ditches, such as the Highway 40 crossing at the upstream end of VIC1 on Vicary Creek. (Photographer: J. Melsted, Catalogue No: RHIP01VIC007)

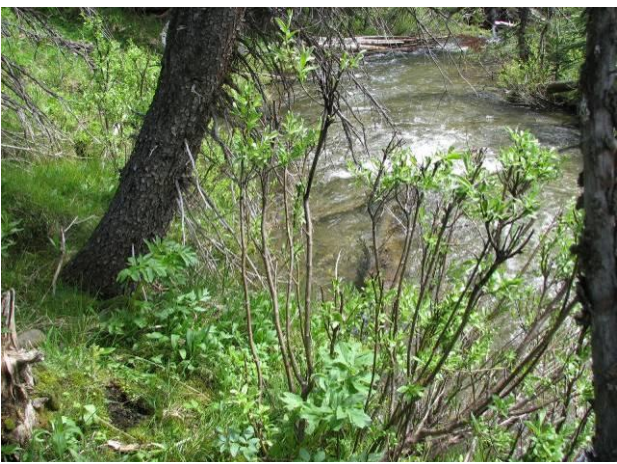
**Photo j:** Browse utilization is minimal in most sites, but moderate along North Racehorse Creek (NRC1) as indicated by flat-topped willows like these. (Photographer: A. Sarrazin, Catalogue No: RHIP01NRC004)

- Highest amounts of browse use were observed in NRC1 which has moderate browse use (**Photo j**, page 18), much of which is due to wildlife use as there is little to no sign of livestock alterations otherwise in this site. Despite moderate browse the NRC1 site has healthy amounts of preferred tree and shrub regeneration and more than 95% cover from woody plants. This indicates that browse levels are likely sustainable and not a management concern.

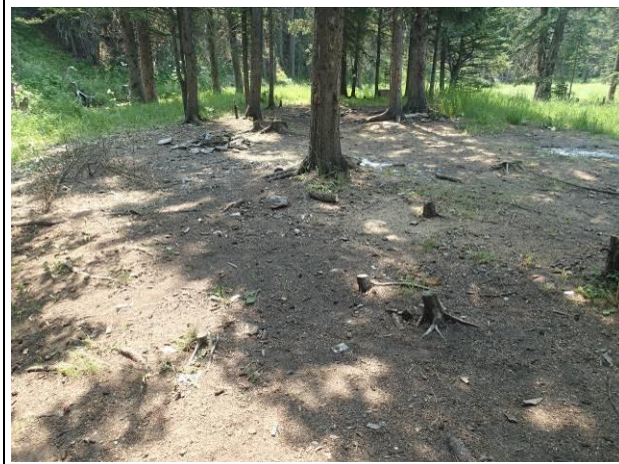
**Photo k:** Human-cut stumps in a random campsite adjacent to Beaver Creek (BVR42). (Photographer: A. Sarrazin, Catalogue No: RHIP42BVR005)

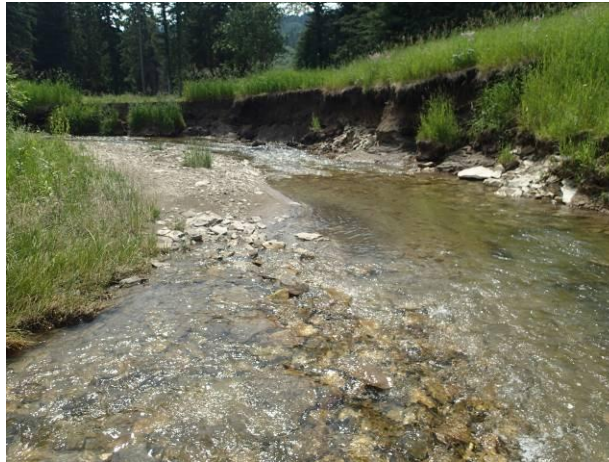
- High cover from disturbance-caused plants has reduced streambank root mass protection ratings to 2/6 for both the TRO1 (**Photo m**, page 23) and BVR42 sites. A rating of 2/6 indicates that root mass protection is lacking in more than 35% of the streambank length.

**Photo m:** Stream reaches like this portion of Beaver Creek (BVR42) have high amounts of bank slumping and accelerated erosion where disturbance-caused shallow-rooted grasses are the primary streambank vegetation cover. (Photographer: A. Sarrazin, Catalogue No: RHIP42BVR017)

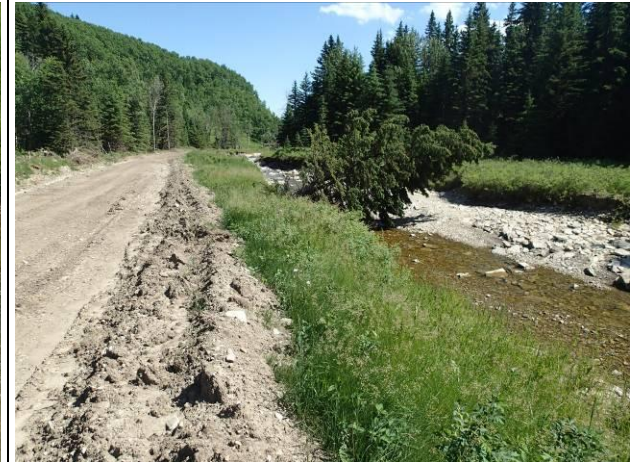
**Photo n:** A logging access road running parallel to Trout Creek has created a source of sediment and contributed to soil compaction and loss of vegetation cover. (Photographer: A. Sarrazin, Catalogue No: RHIP01TRO033)

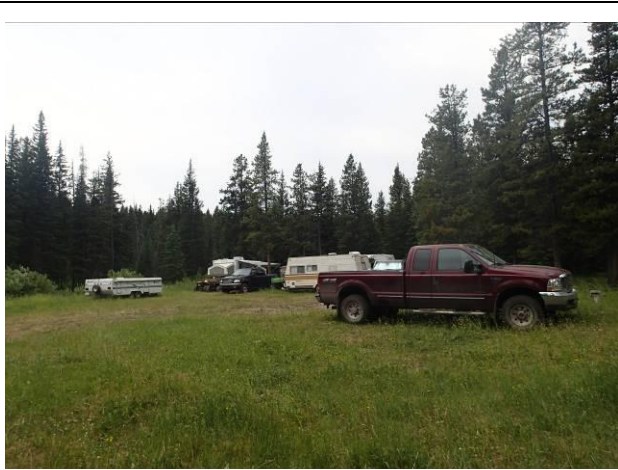
**Photo o:** Random camping is a major contributor to soil compaction, bare ground and native vegetation disturbance in the meadows along the Dutch Creek valley. (Photographer: J. Melsted, Catalogue No: RHIP01DUT007)

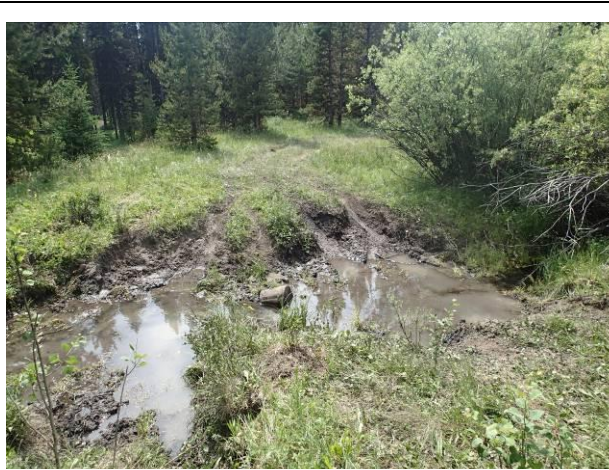
**Photo p:** All terrain vehicle trail rutting, soil compaction and erosion along a tributary of Dutch Creek. (Photographer: J. Melsted, Catalogue No: RHIP01DUT011)

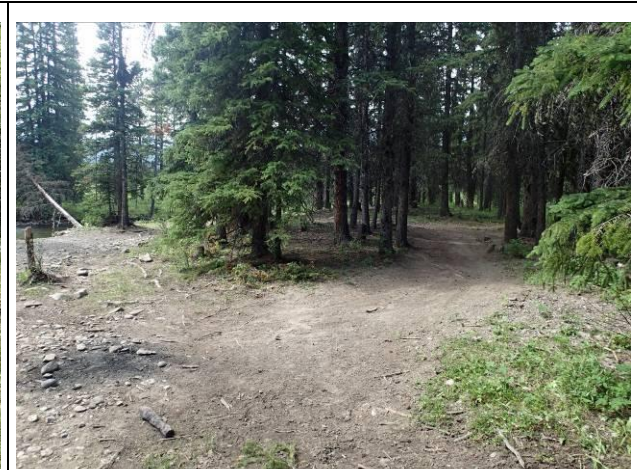
- For the other riparian sites (excluding ‘hotspots’), DUT1 has the highest amount of human-caused bare ground (approximately 10%) due mainly to recreational use impacts from random camping and all terrain vehicle trails (**Photo q**, page 23). Bare ground from cattle trails and hoof shear contributes to a small relative proportion of the overall area of exposed soil in this site.

**Photo q:** Human-caused bare ground is a concern for the 'hotspot' stream crossing reaches and along portions of Dutch Creek with recreational use impacts such as all-terrain vehicle trails. (Photographer: J. Melsted, Catalogue No: RHIP01DUT015)

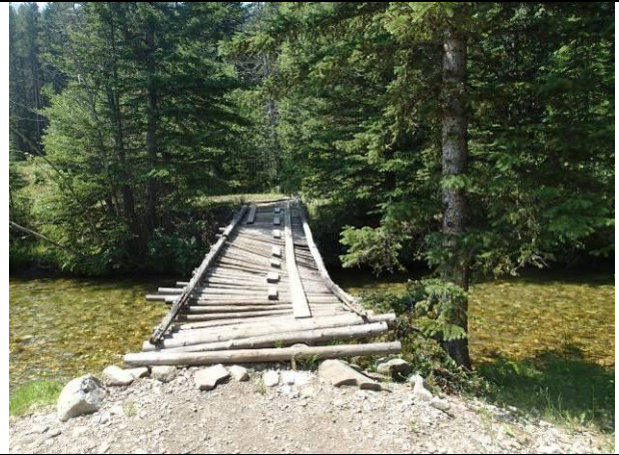
QUAD BRIDGE IN NEED OF REPAIR, UPSTREAM FROM FORDED STREAM CROSSING  
(Photographer: J. Melsted, Catalogue No: RHIP02GOL007)

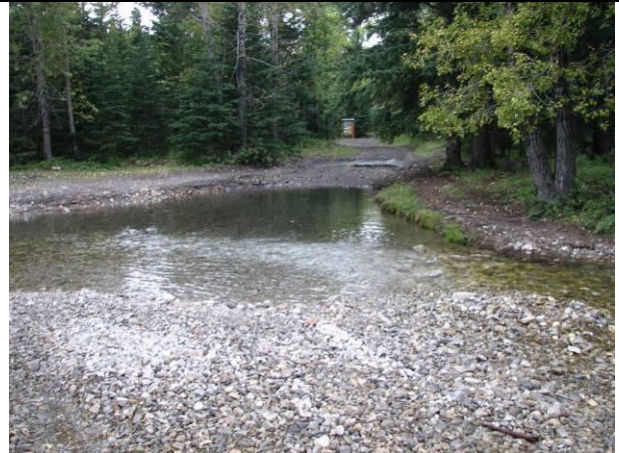
A forded truck trail crossing upstream of the new quad bridge.  
(Photographer: M. Plemel, Catalogue No: RHIP01GRE005)

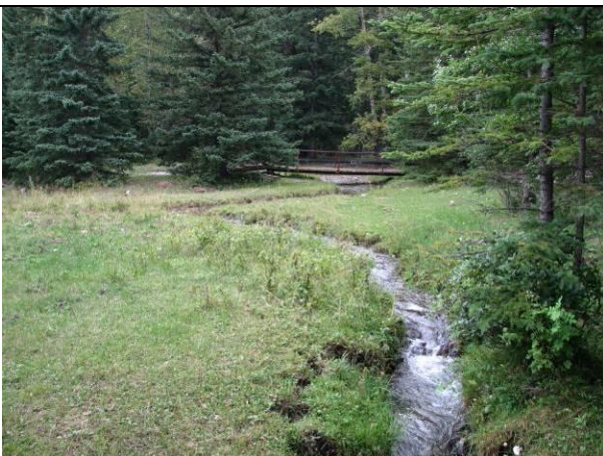
VIEW UPSTREAM TO QUAD BRIDGE  
Disturbed herbaceous vegetation in foreground and bank slumping. This area is a primary use area for livestock.  
(Photographer: M. Plemel, Catalogue No: RHIP01GRE012)

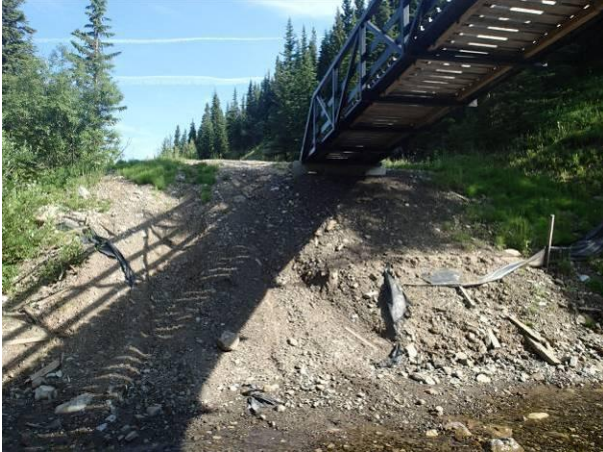
**STREAM CROSSING LEFT BANK.**

Damaged silt fence, approach slope erosion and recent evidence of stream fording. (Photographer: J. Melsted, Catalogue No: RHIP02SMT013)
