2011 Riparian Health Inventory Project: Westslope Cutthroat Trout Priority Streams

*- A Summary of the Riparian Health Status and Habitat Improvement Needs for
20 Priority Westslope Cutthroat Trout Sites in the South Eastern Slopes of Alberta -*

Alberta Riparian Habitat Management Society (Cows and Fish)
Report No. 041

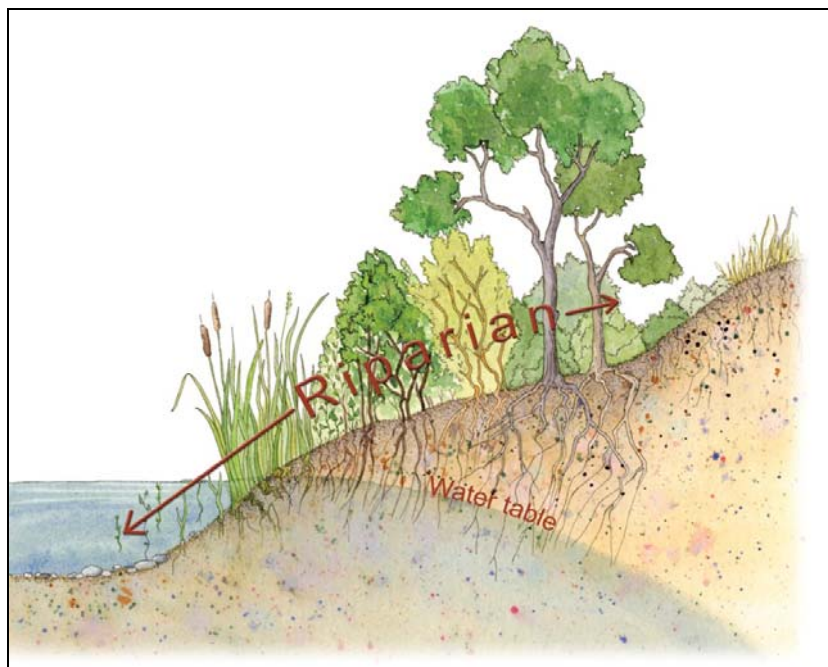
Figure 1. Diagrammatic Representation of a Riparian Area.

When in a properly functioning condition or *healthy* state, riparian areas provide many ecological functions that are beneficial to Westslope Cuthroat Trout. In particular, native riparian vegetation (e.g. sedges, rushes, alders, willow and poplars) helps to:

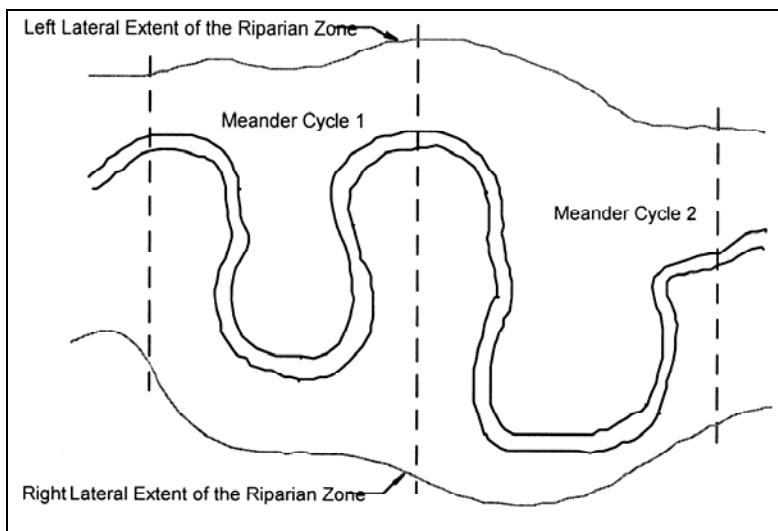
Figure 4. Stream Meander Cycle Diagram.²

For representative RHIs on smaller streams, the length of the reach assessed generally includes at least two channel meander cycles (Figure 4). A complete meander cycle has equal inside and outside curvature. *For this project, reach lengths were confined within the known upper and lower limits of pure Westslope Cutthroat Trout populations based on genetic sampling locations.*

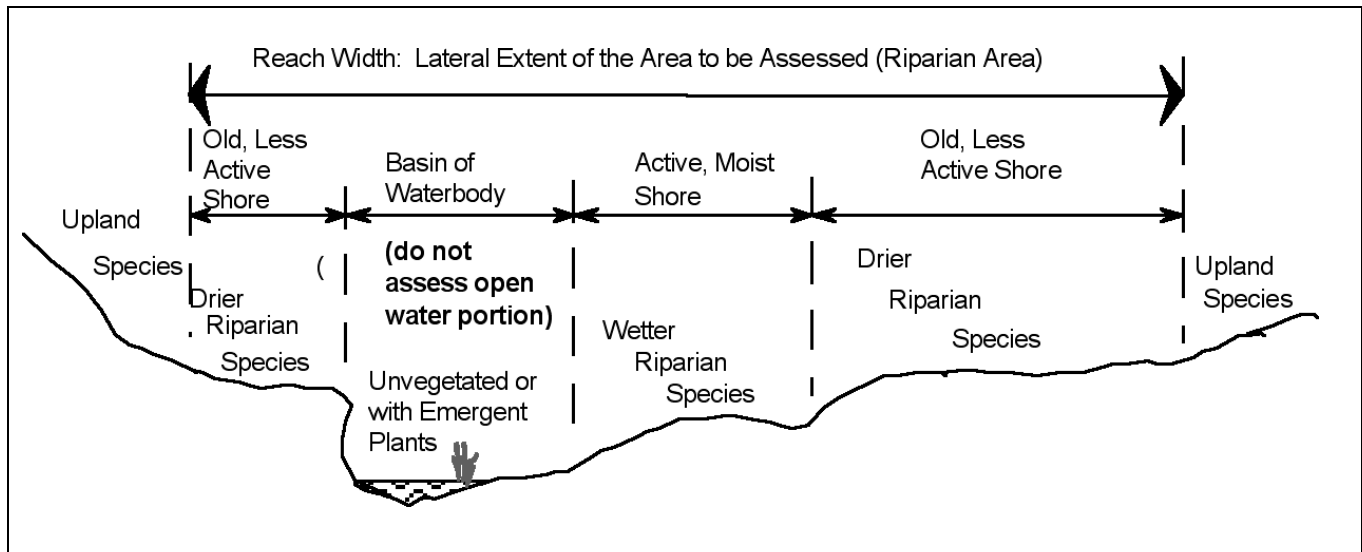
Figure 5. Cross Section Profile of Riparian Area Extent Adjacent to a Stream Channel.

The lateral extent (outer boundary) of the riparian area is determined in the field and traced by hand on an airphoto. The **inner RHI edge** includes the portion of the wetted channel with persistent emergent vegetation (e.g. cattails and sedges). For those situations where there is no emergent vegetation, the wetted channel (aquatic zone) is not included in the assessment. A combination of indicators including vegetation changes, topographic breaks and flood evidence are used to delineate the **outer boundary** of the riparian area (Figure 5).

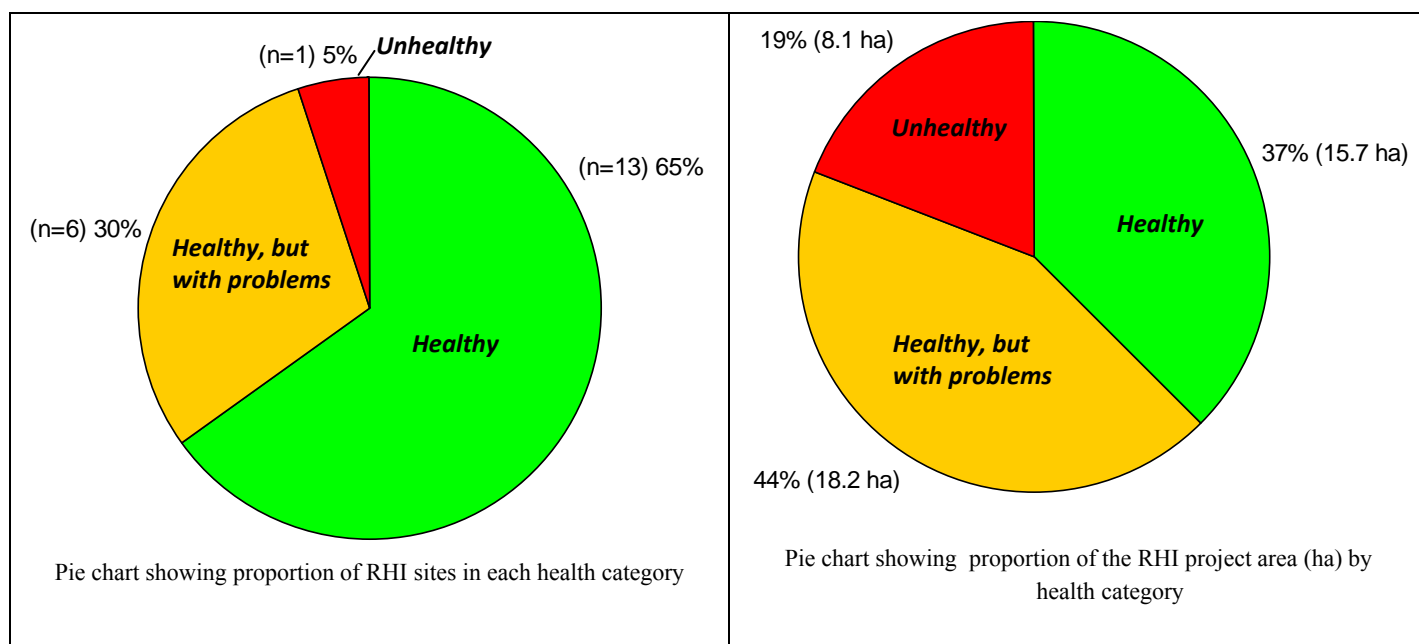
Figure 7. Westslope Cutthroat Trout Project Area Riparian Health Results.

Including the five priority Westslope Cutthroat Trout RHI sites assessed prior to 2011 (Section 2.2), the average riparian health rating for the 20 stream sites evaluated as part of this project is 83% (*healthy*). The majority of sites (13 sites) (i.e. 65%) rate *healthy*, 6 sites (i.e. 30%) rate *healthy, but with problems* and only 1 site is in the *unhealthy* category (Figure 7, Table 7). The total project area encompasses 42.0 ha of riparian habitat along 13.8 km of stream length.

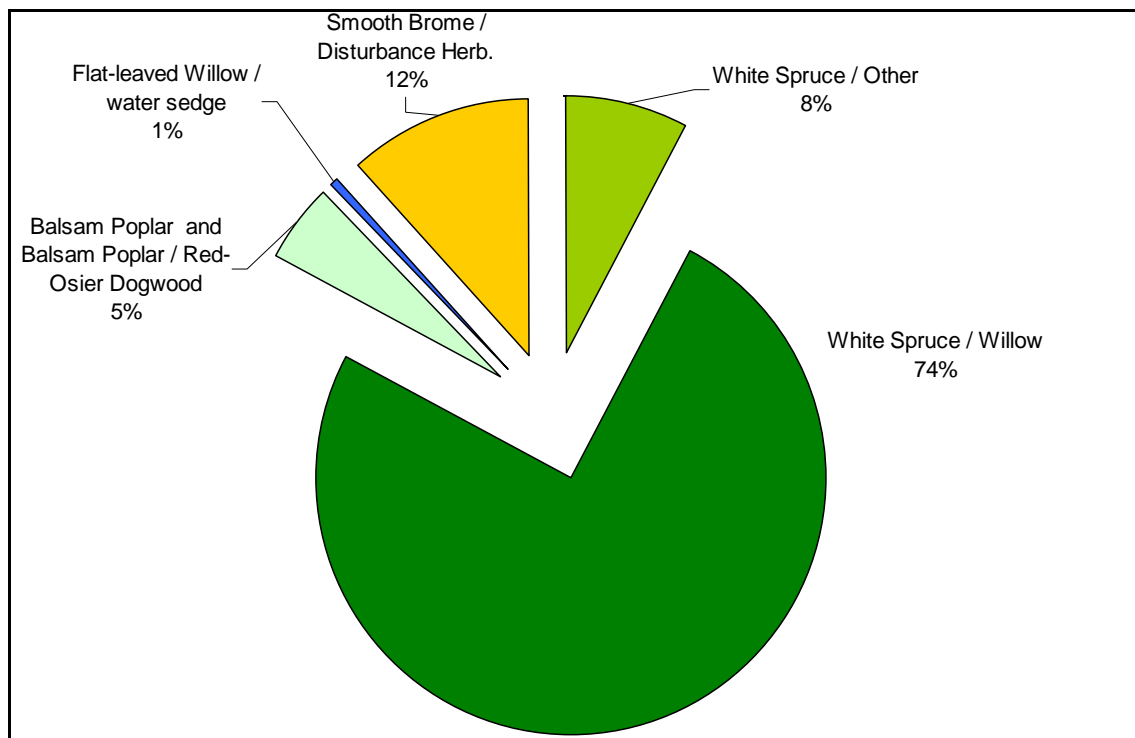
Figure 9. Dominant Plant Community Types in the Project Area.

Three other white spruce community types collectively comprise 8% of the project area (Table 8, Figure 9). These types have either an understory of common horsetail (*Equisetum arvense*), moss (Photo b, page 21), or thimbleberry (*Rubus parviflorus*). Coniferous communities with a moss or horsetail understory provide very little herbaceous forage for livestock and are generally considered ‘non-use’ community types. Moss and horsetail understory vegetation is sensitive to high intensity land uses (e.g. OHV use or frequent trampling by livestock). Deciduous tree communities (e.g. balsam poplar [*Populus balsamifera*] types) provide higher amounts of preferred forage for livestock and wild ungulates but only comprise about 5% of the project area (Table 8).

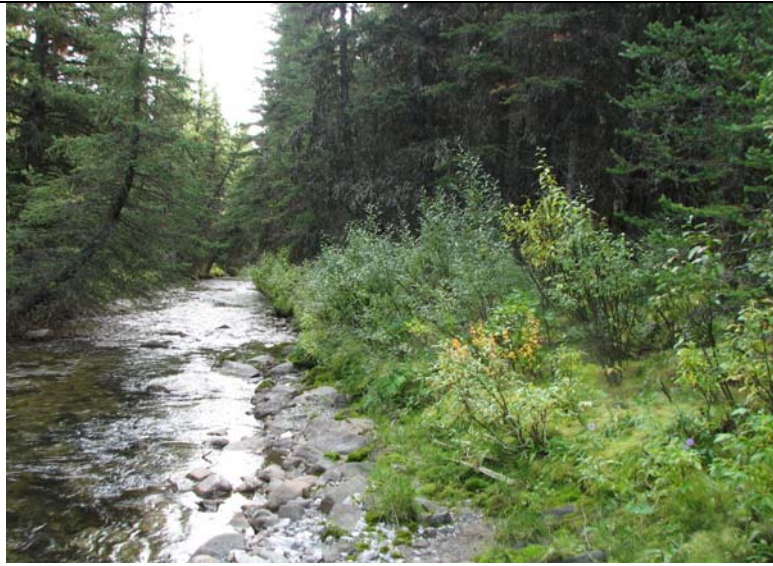
C. Wood, RHIP01HID006

Photo a: A white spruce / willow Habitat Type is the characteristic plant community along most of the Westslope Cutthroat Trout mountain streams in the project area.

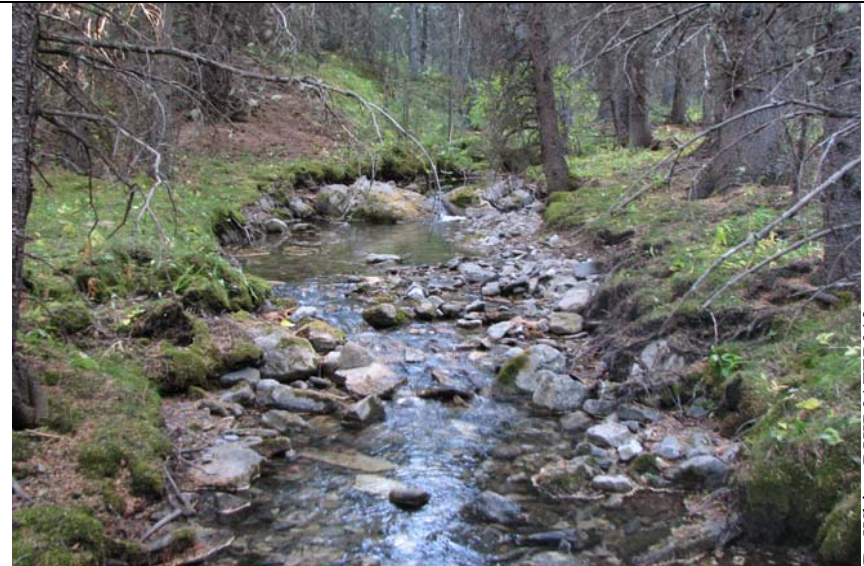
D. White, RHIP01ZEP013

Photo b: A dense, shaded white spruce / moss community occurs along the upper reaches of Zephyr Creek. This community has low herbage production value for livestock, but it does offer suitable habitat conditions for Westslope Cutthroat Trout.

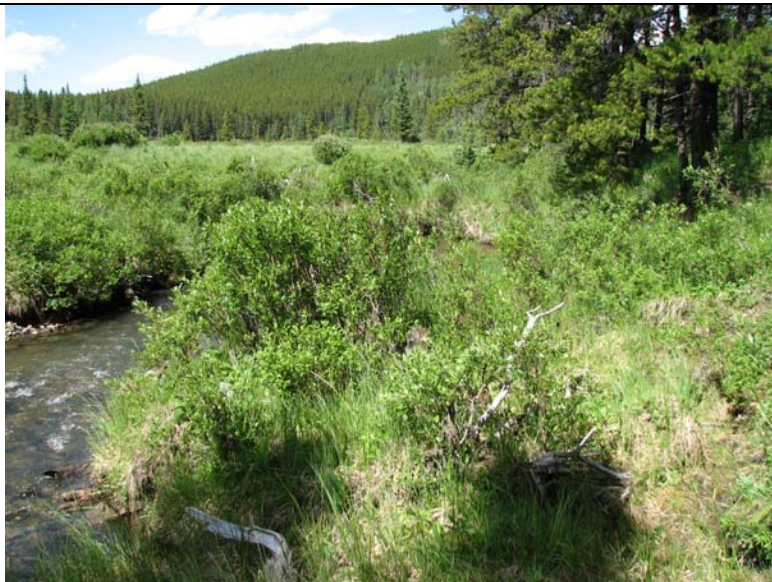
C. Ball, RHIP01WAZ002

Lush, beaver modified wet meadow habitat along a tributary to Waiparous Creek (WAZ1) is characterized by a flat-leaved willow (*Salix planifolia*) – water sedge (*Carex aquatilis*) Habitat Type (Photo c, page 21). This Habitat Type is unique to this site in our project area. This Habitat Type is particularly susceptible to soil compaction impacts from livestock or recreational uses due to fine textured and saturated soil conditions.

Photo c: The beaver modified lush meadow habitat along a tributary to Waiparous Creek (WAZ1) is characterized by a Flat-leaved Willow / Water Sedge Habitat Type.

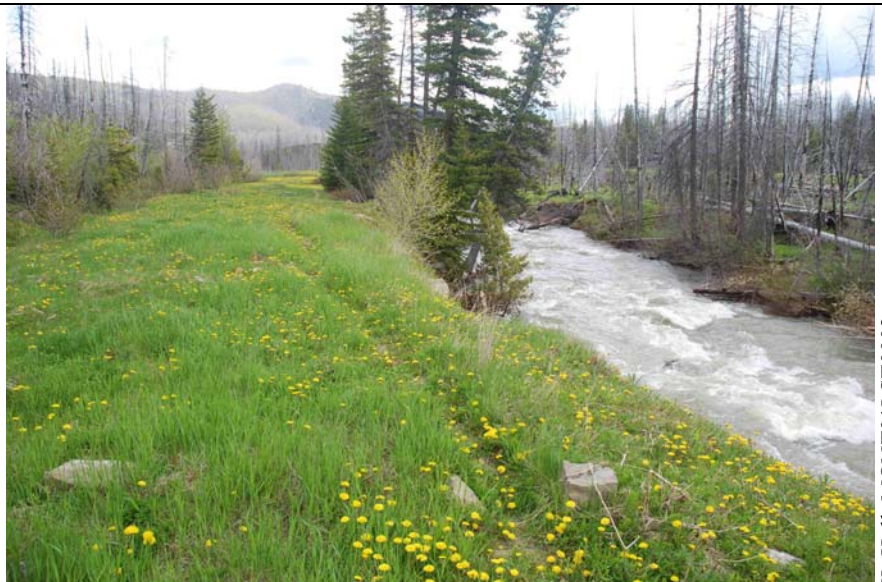
K. Hull, MONT01LST002

Non-native disturbance-caused herbaceous community types (Photo d, page 21) are fairly abundant, making up almost 12% of the project area (Table 8, Figure 9). These communities mainly occur in disturbed open meadows that have been impacted by historical or ongoing cumulative land uses (e.g. grazing, forestry, recreation, industrial development etc.). These communities are generally dominated by a mix of introduced (i.e. non-native) and / or weedy species such as Kentucky bluegrass, timothy (*Phleum pratense*), quack grass (*Agropyron repens*), smooth brome (*Bromus inermis*), alsike

Photo d: Disturbed meadow habitats associated with old roadways, OHV trails, random campsites or in areas with heavy livestock use are characterized by disturbance-caused herbaceous community types with high cover from introduced grasses and / or weedy species.

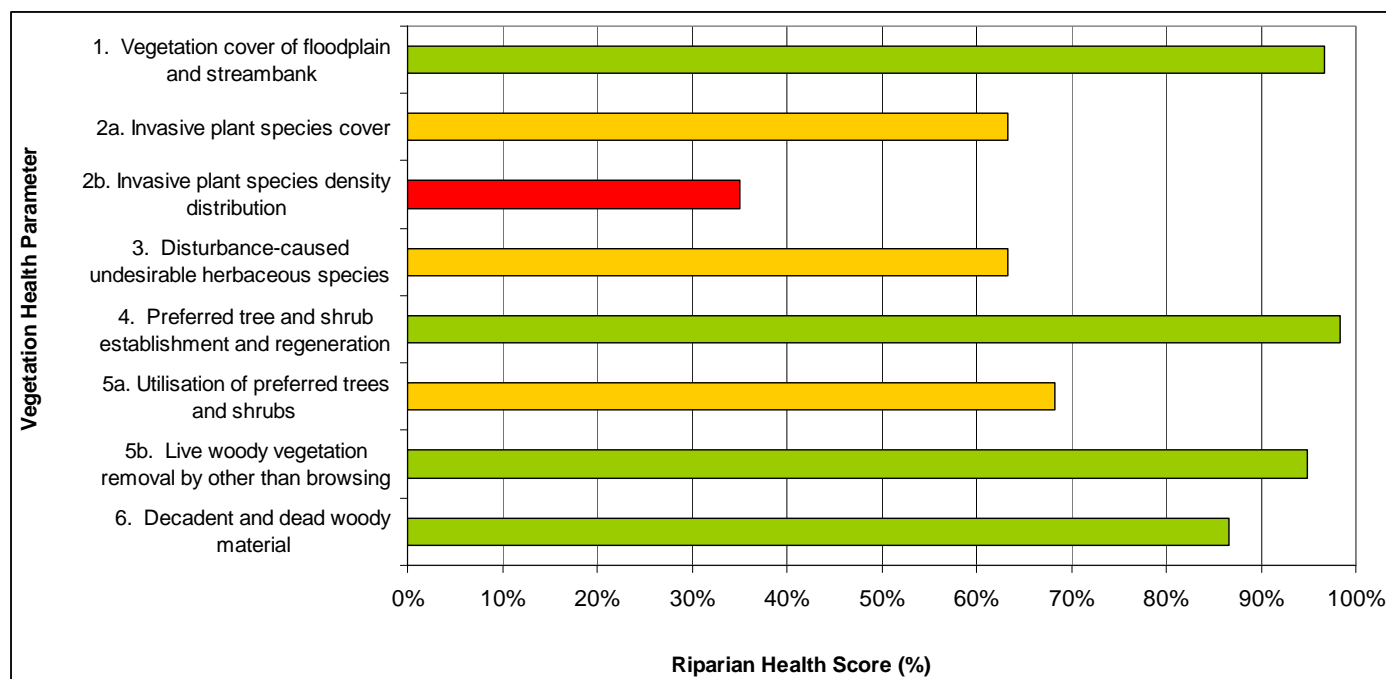
Figure 10. Vegetation Health Parameter Results.

The average vegetation health rating for the Westslope Cutthroat Trout RHI sites is 80% (*Healthy*). With some exceptions, most sites have more than 95% vegetation cover in the riparian area, healthy levels of establishment and regeneration of native trees and shrubs, low levels of woody vegetation removal by beavers or humans, and low levels of dead and decadent trees and shrubs (Figure 10). Of concern are invasive and non-native disturbance-caused species which are fairly widespread in some sites. As well, five sites have moderate to heavy levels of woody browse (Figure 10).

- **Non-native disturbance-caused plants are widespread in the project area.** Six of the 20 sites have greater than 25% of the riparian area covered in disturbance-caused herbaceous species (Figure 10). These species cover approximately 41% of the project area.

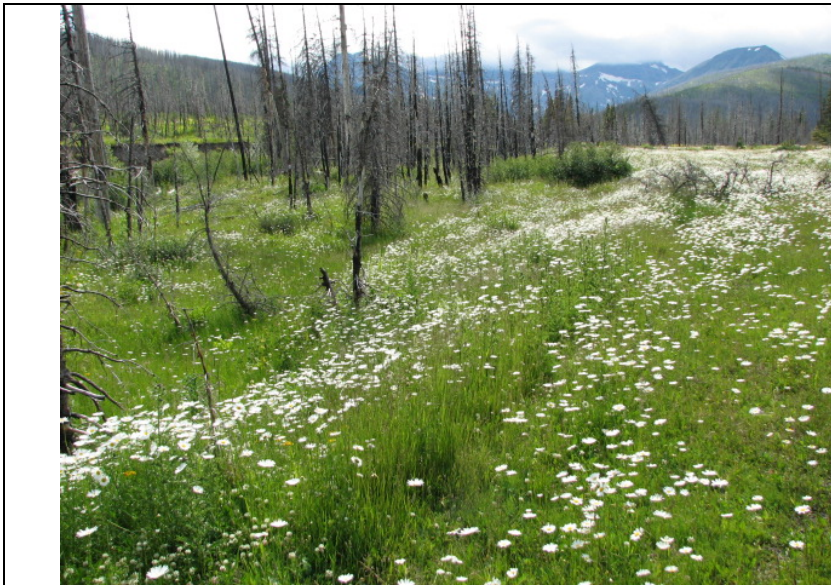
K. Stebanuk, RHIP01LST017

Photo e: Ox-eye daisy is especially abundant along Lost Creek where it is encroaching from an old (inactive) road that parallels the north side of the creek.

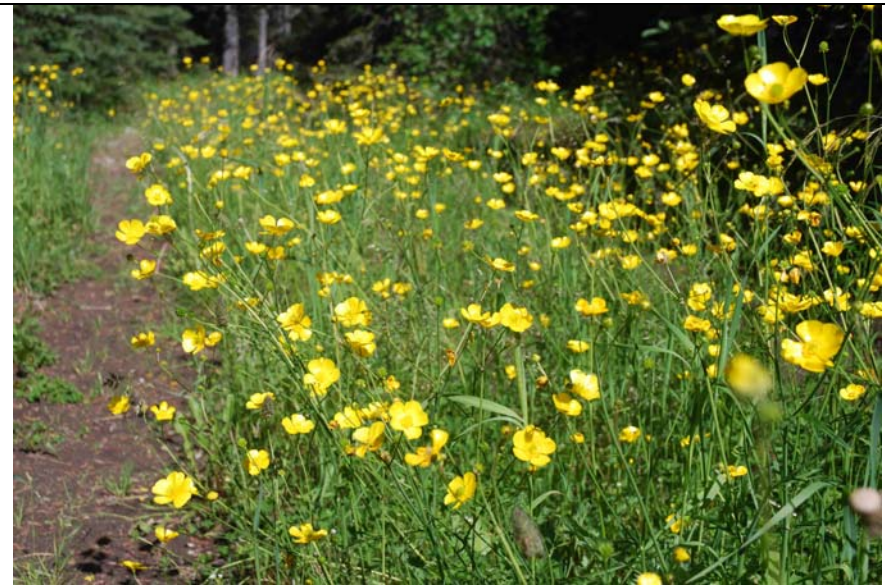
K. Hull, RHASIPS0045

Photo f: Tall buttercup occurs in 60% of the RHI sites. It is especially abundant along Johnson Creek (JOH3) and the unnamed tributary to Johnson Creek (JOY1) in the Willow Creek Watershed.

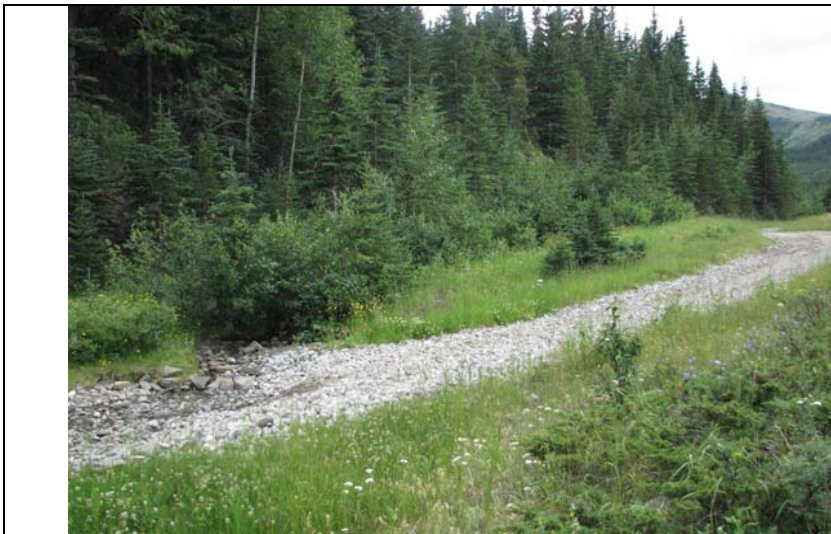
K. Stebanuk, RHIP03JOH005

Photo g: Non-native, disturbance-caused species like Kentucky bluegrass, timothy, clovers and dandelion are encroaching into riparian sites from disturbed roadsides and trails in the project area

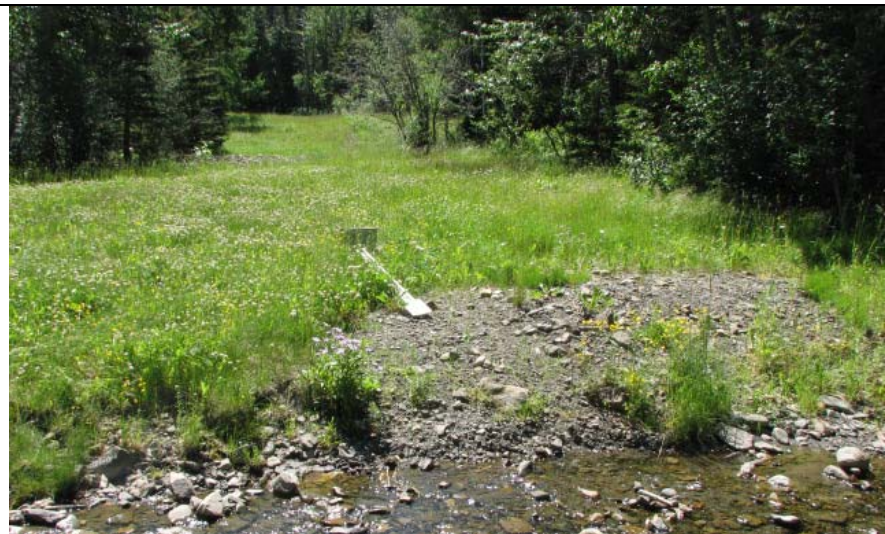
C. Wood, RHIP01JOY008

Photo h: Pipeline rights-of-way are another source of non-native disturbance-caused herbaceous species, such as this pipeline crossing near the downstream end of the unnamed Johnson Creek tributary (JOY1). Disturbance-caused plants lack deep binding roots, contributing to outward channel erosion here.

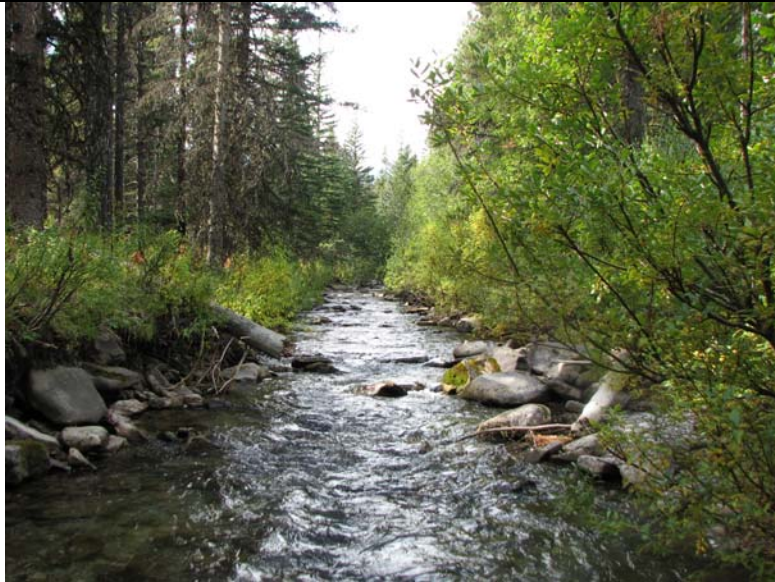
D. White, RHIP02HID010

Photo i: The majority of the project area has healthy levels of riparian vegetation cover from a diversity of native plant species, in particular white spruce and willow species.

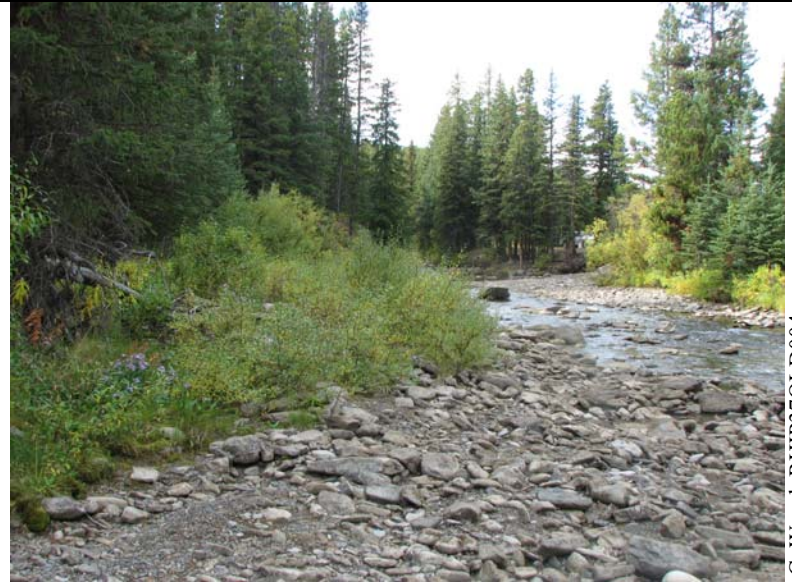
C. Wood, RHIP37OLD004

Photo j: There are healthy levels of native tree and shrub regeneration in most sites. New willow growth is especially common along newly deposited alluvial point bars.

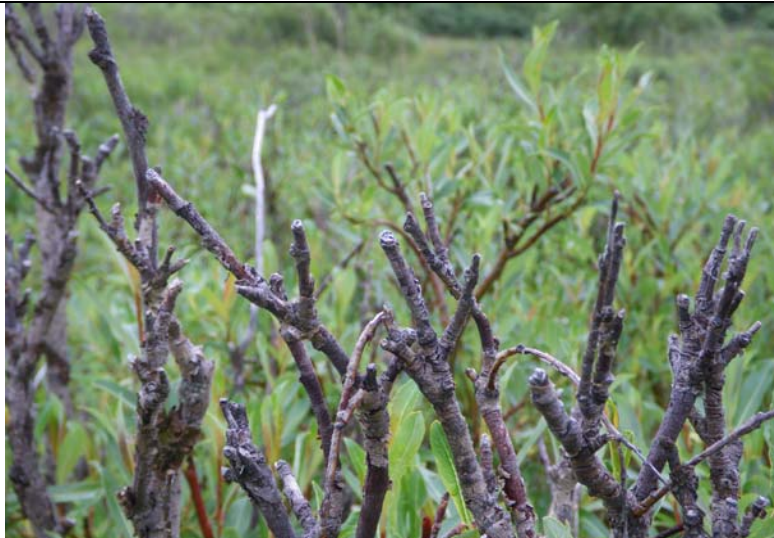
K. Hull, RHASUTS0014

Photo k: Five RHI sites have moderate to heavy levels of browse utilization of preferred woody forage species such as willows. This browse pressure is likely from a combination of livestock and wildlife use. Heavily browsed shrubs have a hedged or 'flat-topped' appearance.

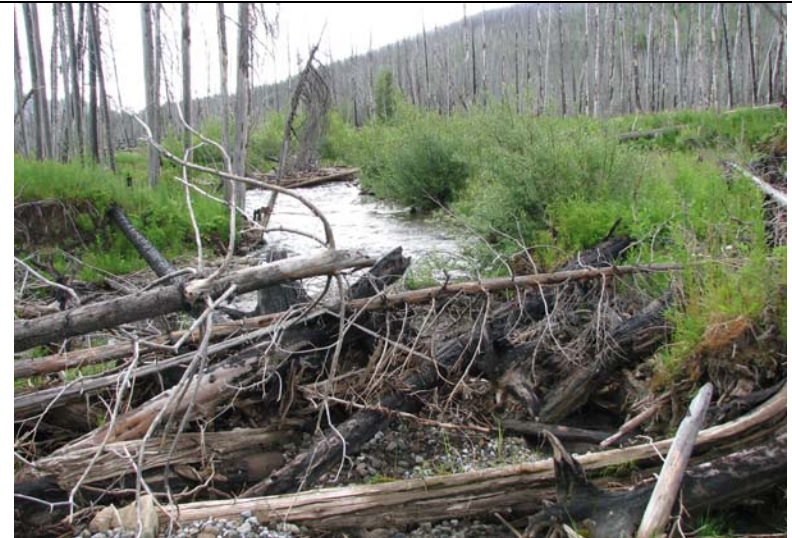
D. White, RHIP01NLS003

Photo l: The 2003 Lost Creek fire resulted in extensive fire damage to riparian sites along Lost Creek, North Lost Creek and Lynx Creek in the Castle River watershed. New re-growth of willows is helping to offset loss of root-mass protection along portions of the fire impacted reaches.

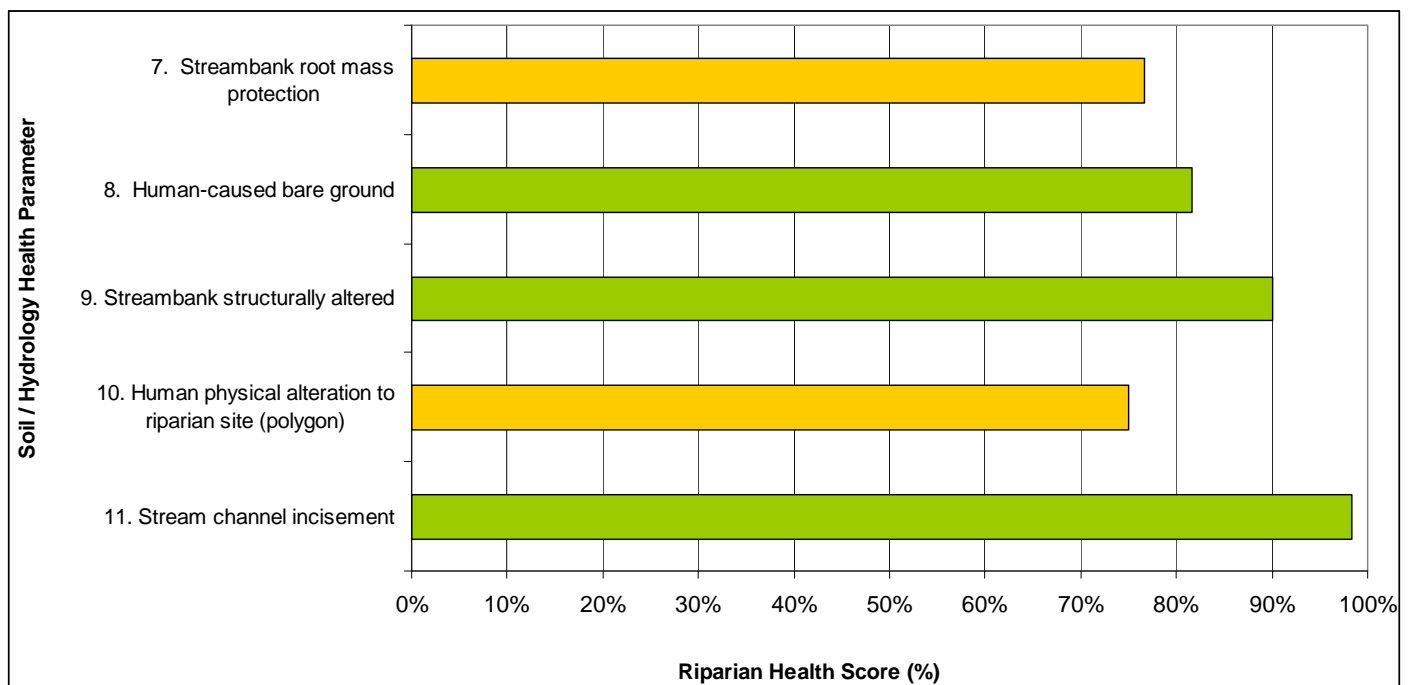
Figure 11. Soil / Hydrology Health Parameter Results.

The average soil / hydrology health rating for the Westslope Cutthroat Trout RHI sites is 87% (*Healthy*). Most sites have minimal amounts of human-caused bare ground, few streambank structural alterations and unincised channel profiles that allow for natural flooding to occur unimpeded (Figure 11). Natural and human-caused land use disturbances have contributed to slightly to moderately reduced levels of streambank root mass protection in 50% of the sites (Figure 11). Human-caused soil compaction and alterations in the floodplain beyond the bank are a concern in 10 sites, 4 of which have severe amounts of alterations (>15%), while 6 others have minor amounts of alterations (>5%).

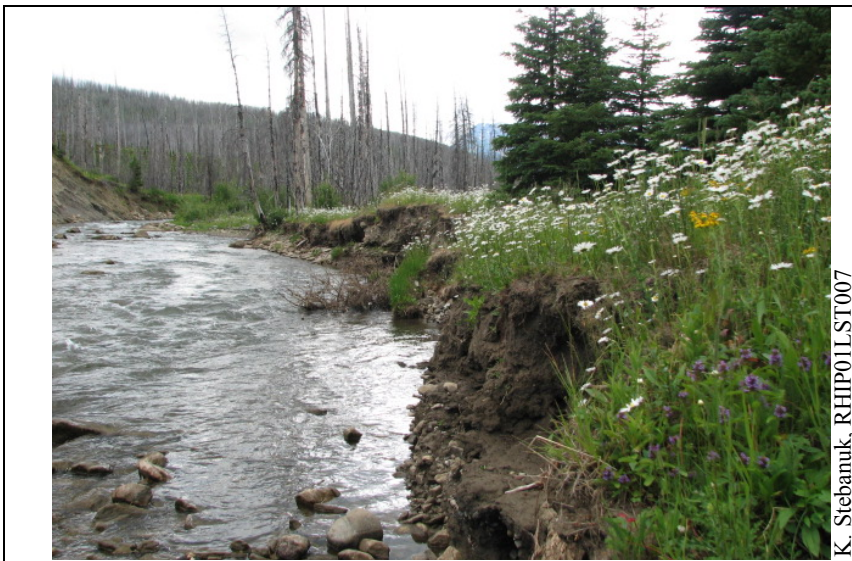
K. Stebanuk, RHIP01LST007

Photo m: Ox-eye daisy is prolific along portions of Lynx Creek. This shallow-rooted, invasive species does not provide sufficient root-mass protection to stabilize streambanks and prevent accelerated rates of erosion.

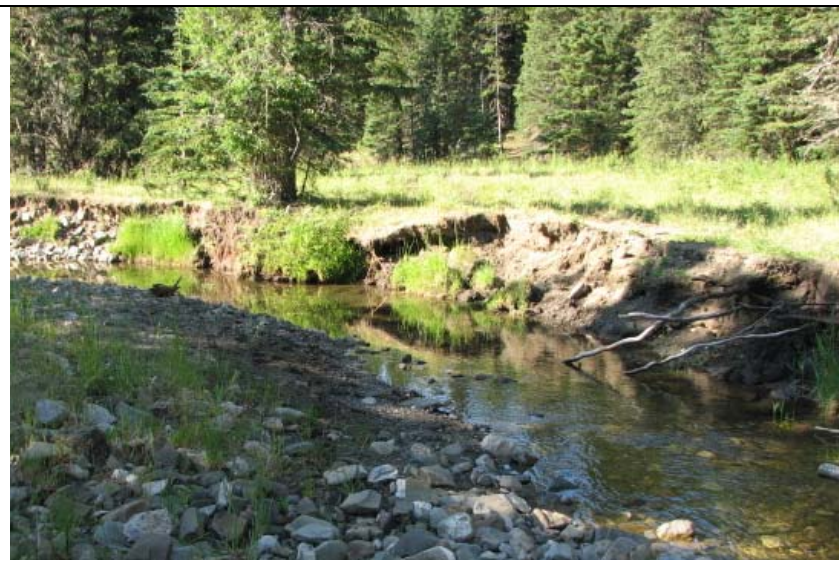
C. wood, RHIP15WIL008

Photo n: Streambank reaches with high cover from non-native disturbance-caused species such as Kentucky bluegrass are subject to accelerated rates of erosion and bank slumping due to absence of deeply rooted plants.

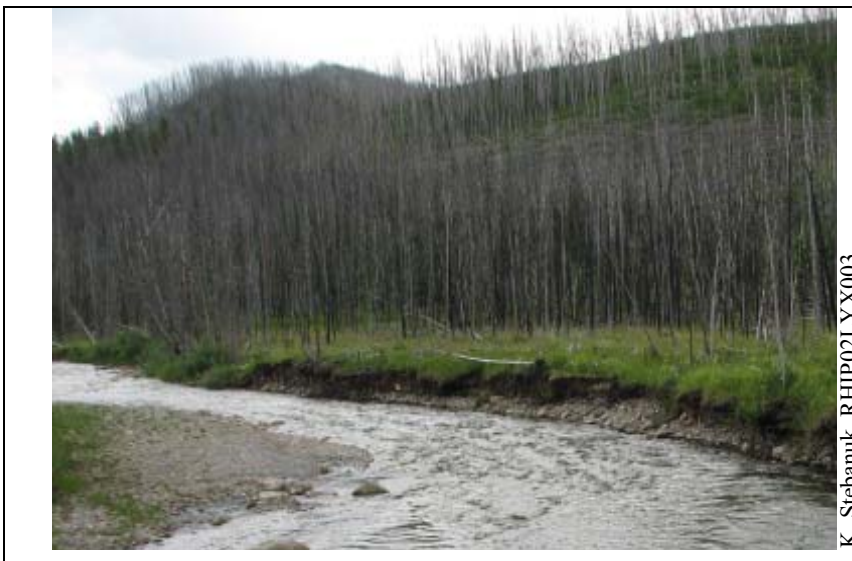
K. Stebanuk, RHIP02LYX003

Photo o: The 2003 Lost Creek fire has contributed to reduced root mass protection along streambank reaches with fire killed trees.

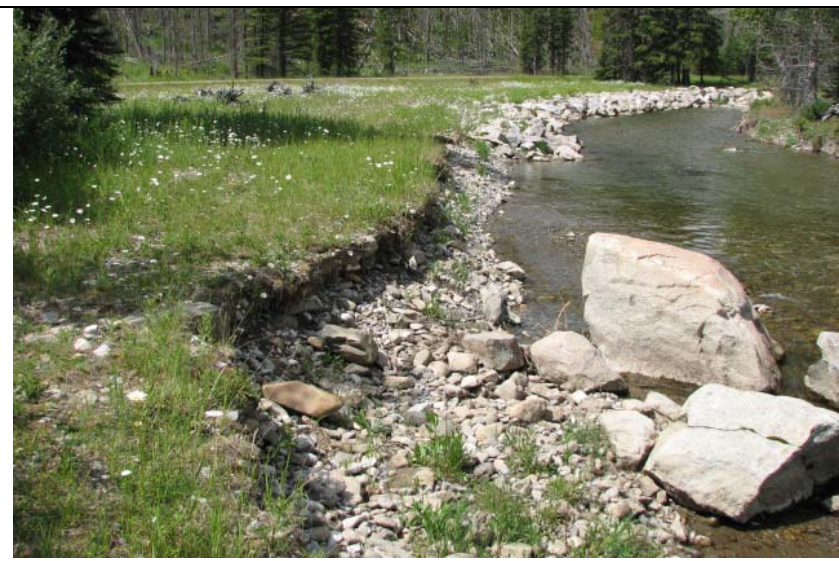
K. Stebanuk, RHIP02LYX016

Photo p: Portions of the upper reach of Lynx Creek have been altered due to rip-rap bank armoring adjacent to the gravel road. Rip-rap removes important shelter and cover habitat and it can contribute to accelerated rates of erosion downstream or channel widening where floodwater erodes behind the rip-rap as in this photograph.

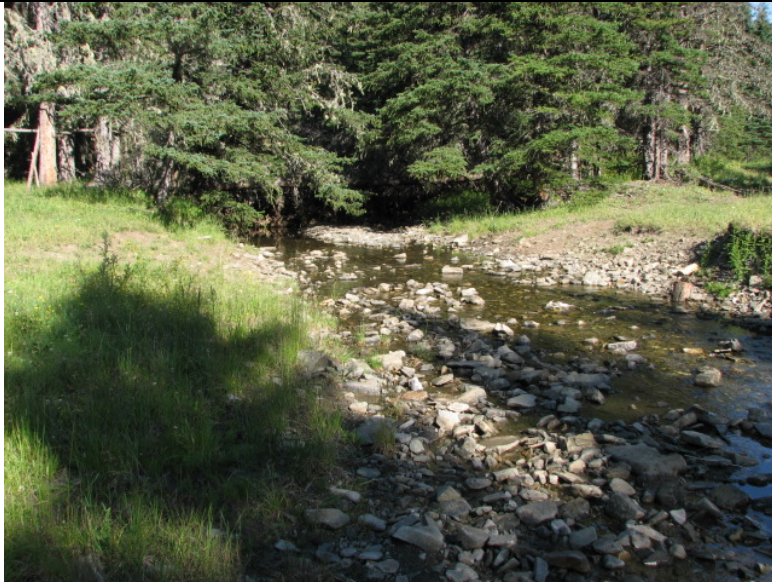
C. Wood, RHIP15WIL009.

Photo q: Most of the inventoried stream reaches in the project area have only isolated streambank alterations such as from stream crossings.

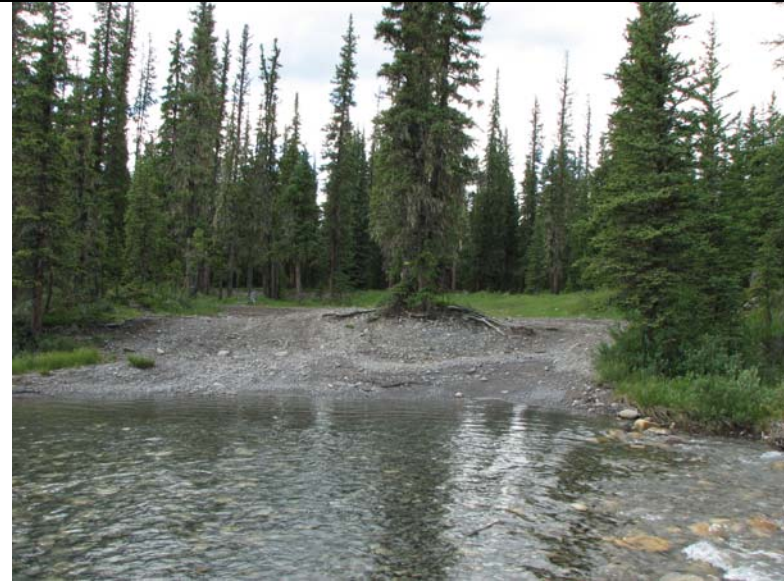
C. Wood, RHIP01JON005

Photo r: Intensively used OHV stream crossings, although small in extent, can have potentially severe negative impacts to water quality especially where crossing locations impact highly erodible fine-textured soils.

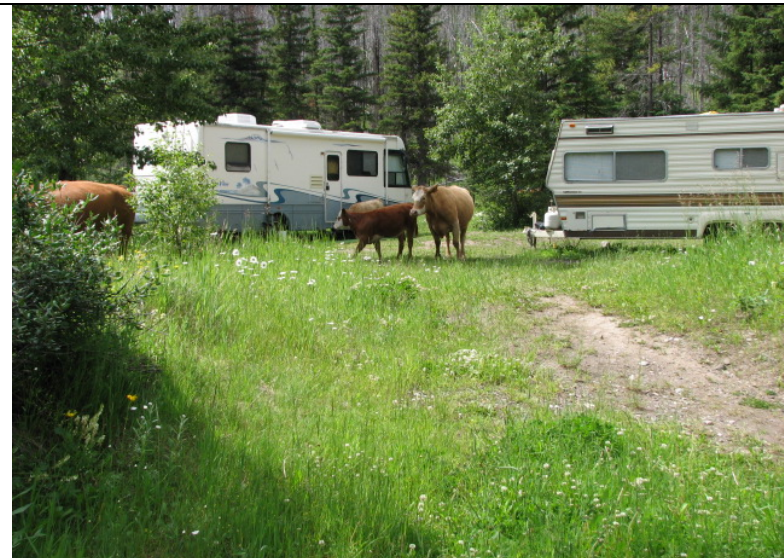
K. Stebanuk, RHIP02LYX017

Photo s: Recreational activities are the primary cause of soil compaction and bare ground in the project area. Of particular concern are heavy OHV impacts to a portion of the Johnson Creek floodplain in the Waiparous Creek watershed.

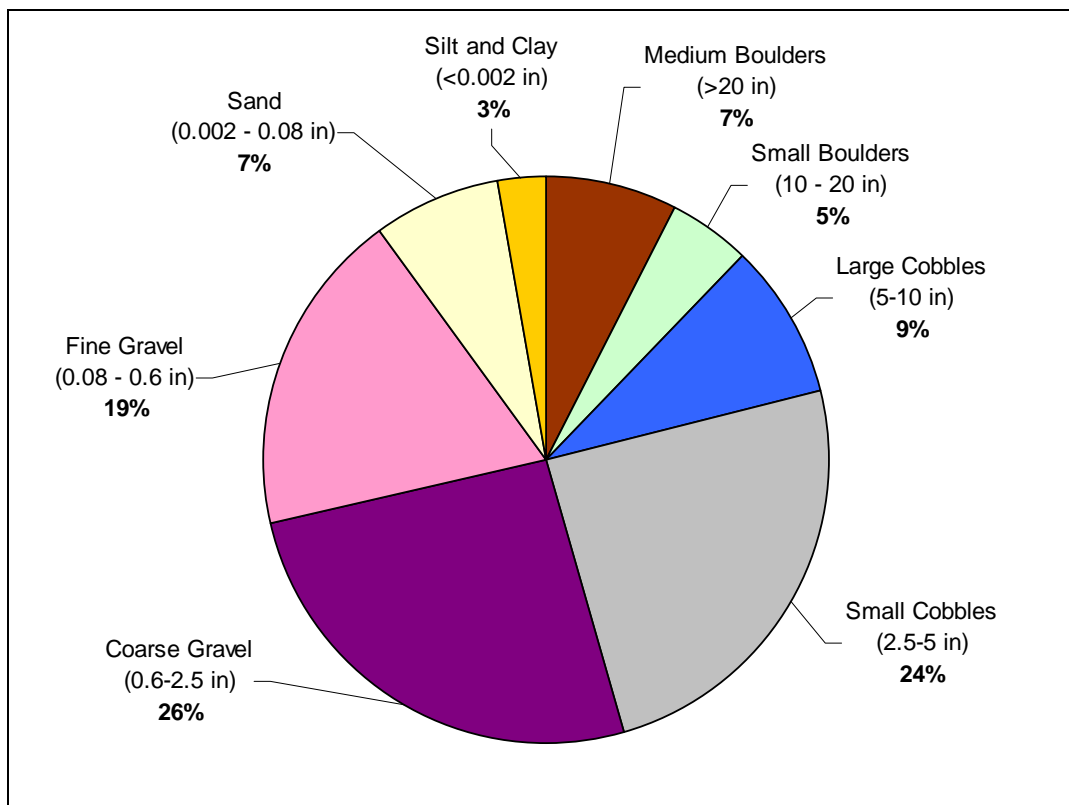
Figure 12. Average Channel Substrate Composition in the 2011 RHI Project Area.

In keeping with described habitat preferences for Westslope Cutthroat Trout, the 2011 RHI stream channel reaches are mainly comprised of a mix of coarse gravel (26%), small cobbles (24%), fine gravel (19%) and large cobbles (9%) (Table 9, Figure 12). Small and medium boulders are also commonly occurring along the assessed reaches. *Detailed stream channel substrate data are given in Appendix D.*

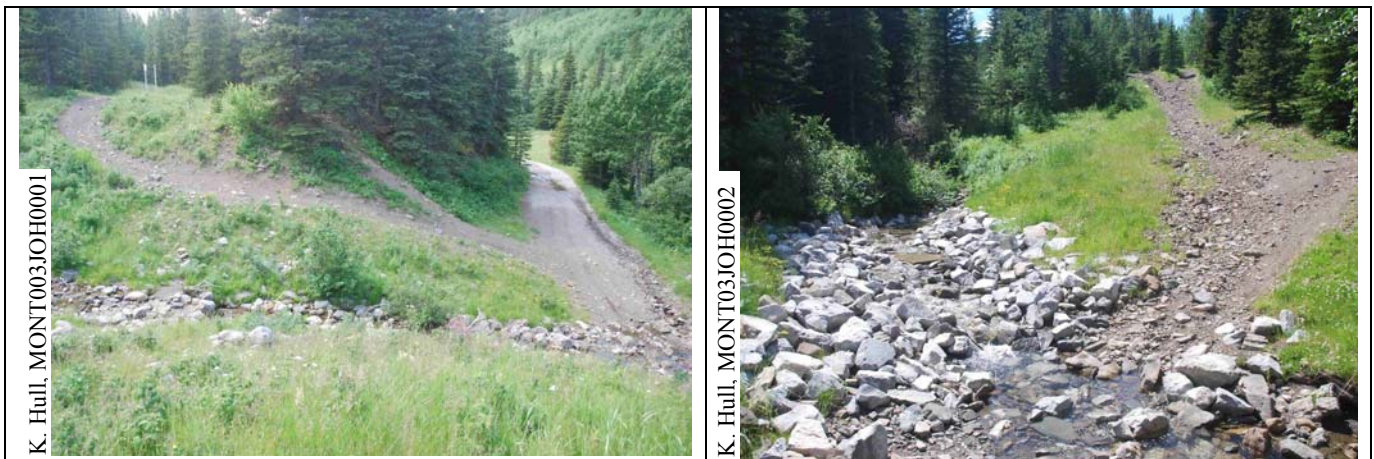
On average, most of the 2011 RHI reaches have channel bottoms comprised of less than 5% silt and clay (Table 9). Exceptions include COL1 (the downstream reach of Corral Creek), LYX2 (the upper reach of Lynx Creek), LST1 (Lost Creek) and JOH3 (Johnson Creek in the Willow Creek watershed). Human-caused alterations to the bank and the floodplain combined with reduced root mass protection may be contributing factors to elevated levels of channel siltation for the COL1 and LYX2 sites. Erosion of OHV trails upslope from JOH3 may be contributing to sedimentation of this stream.

Photos u and v: Several OHV trails occur in the uplands immediately adjacent to **JOH3**, several of which cross small, steep tributaries that feed directly into Johnson Creek.

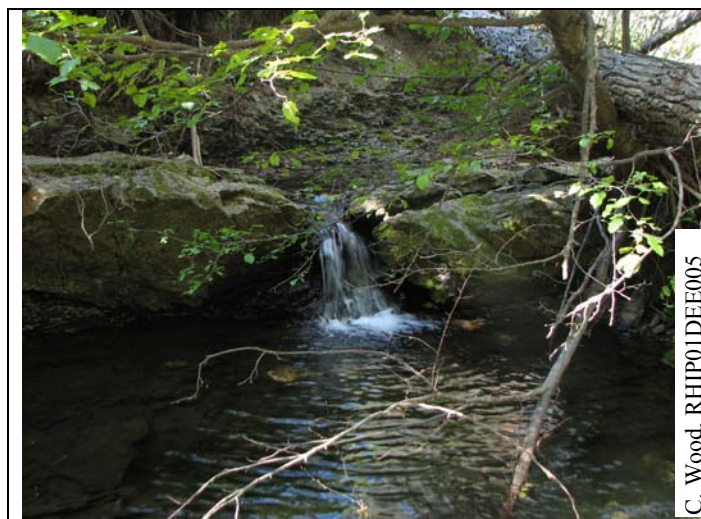
Photo w: Natural rock fall along Deep Creek (possible barrier to fish movement during low flow periods).

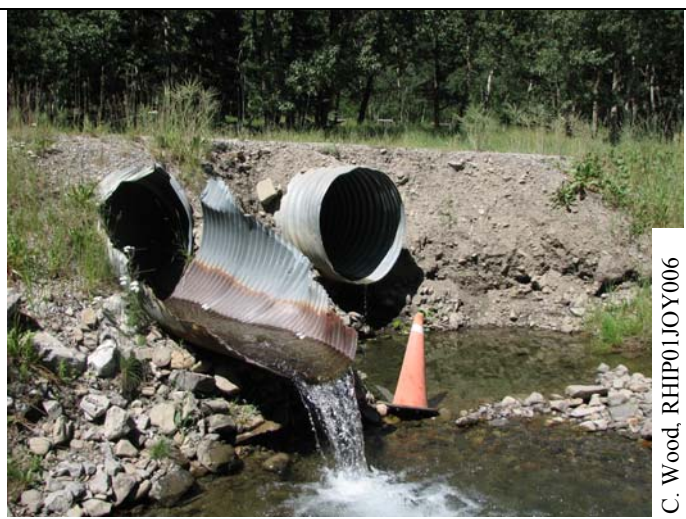
Photo x: Hanging culvert (barrier to fish passage) at the downstream end of JOY1.

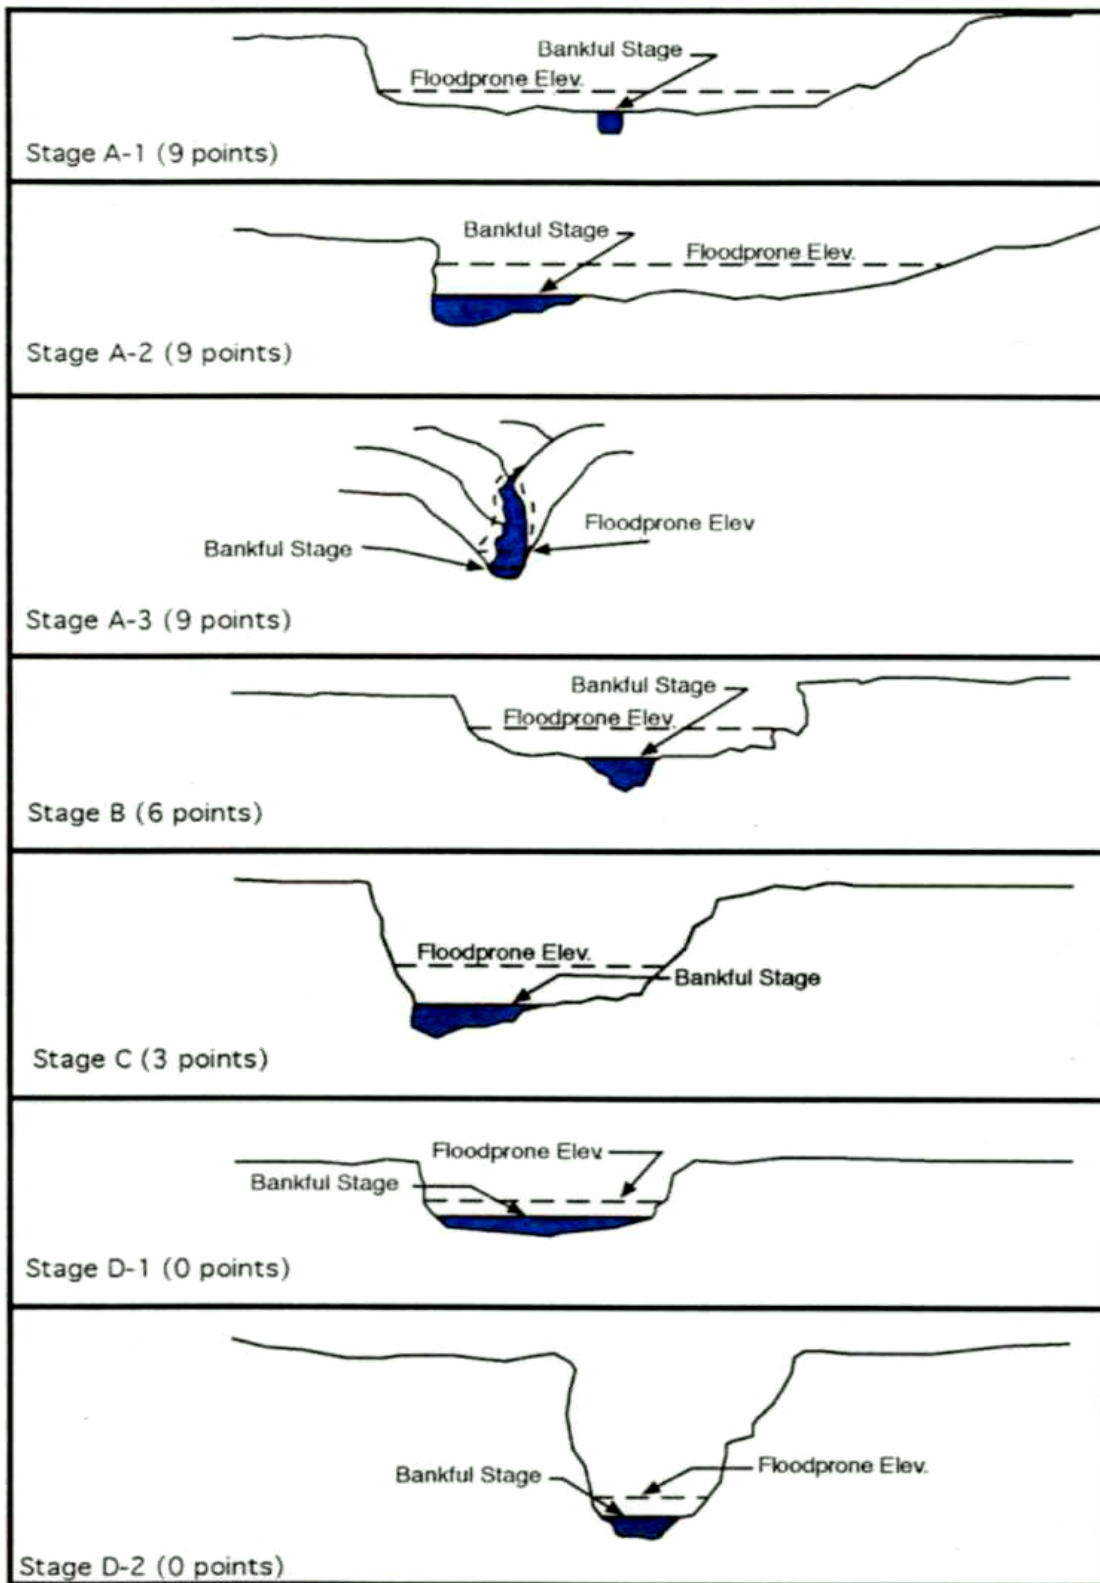
Figure 2. Guides for estimating stage of channel incisement.

Stage D-2. A narrow, deep “gully” system (Rosgen G-type) downcut to the point that only extreme floods can overtop the banks. Distinguished from narrow mountain streams (A-type) by the presence of a flat floodplain through which the stream has downcut and by banks consisting of fine materials rather than larger rocks, cobbles, or boulders.
