2011 to 2015 Highlights Summary: Westslope Cutthroat Trout Riparian Health Evaluation, Public Outreach and Habitat Improvement Initiative

Alberta Riparian Habitat Management Society (Cows and Fish)
Report No. 045

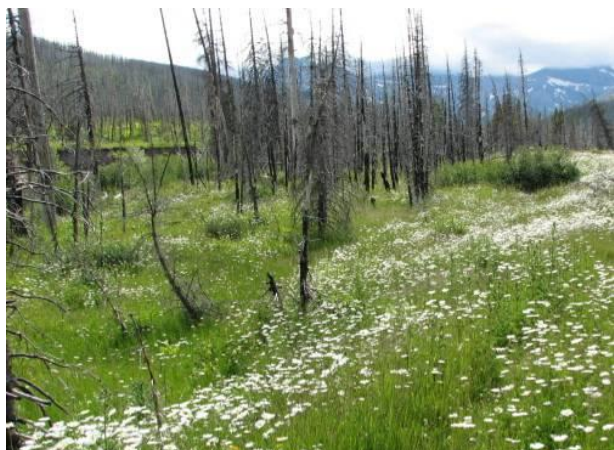
Ox-eye daisy is especially abundant along Lost Creek where it is encroaching from an old (inactive) road that parallels the north side of the creek. (Photographer: K. Stebanuk, Catalogue No: RHIP01LST017)

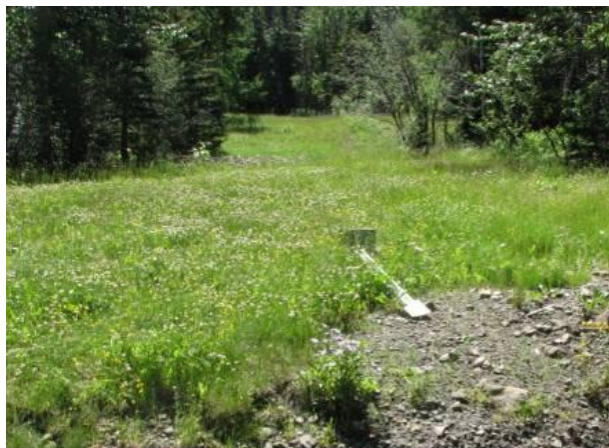
Pipeline rights-of-way are another source of non-native disturbance-caused herbaceous species, such as this pipeline crossing near the downstream end of the unnamed Johnson Creek tributary (JOY1). Disturbance-caused plants lack deep binding roots, contributing to outward channel erosion here. (Photographer: C. Wood, Catalogue No: RHIP01JOY008)

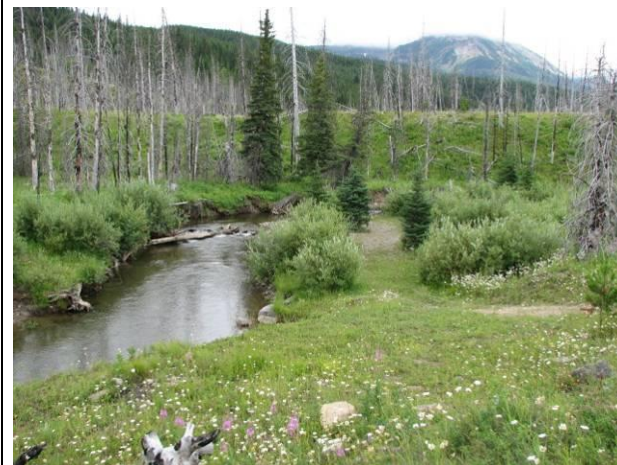
Disturbance-caused herbaceous plants like Kentucky bluegrass and others in addition to the invasive ox-eye daisy have encroached into fire disturbed areas along the Carbondale River (CRB2). (Photographer: K. Low, Catalogue No: RHIP02CRB016)

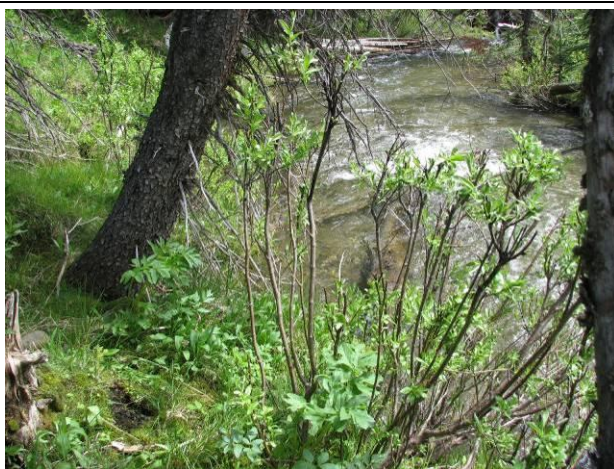
Browse is minimal in most sites, but moderate along North Racehorse Creek (NRC1) as indicated by flat-topped willows like these. (Photographer: A. Sarrazin, Catalogue No: RHIP01NRC004)

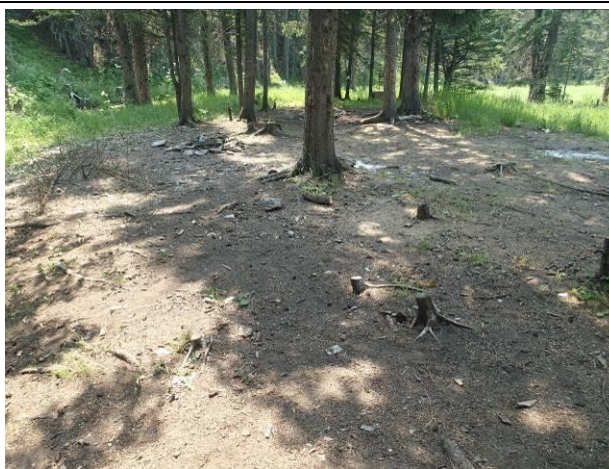
Human-cut stumps in a random campsite adjacent to Beaver Creek (BVR42). (Photographer: A. Sarrazin, Catalogue No: RHIP42BVR005)

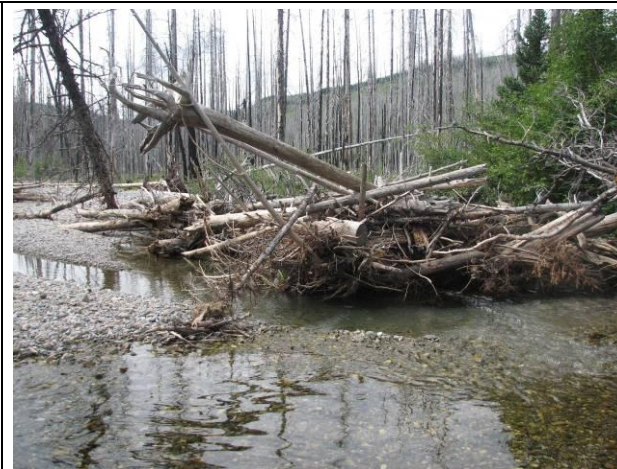
Lynx Creek sites have high levels of dead and decadent woody material due to fire; fire killed trees are susceptible to floods and winds, creating log jams and high in-stream woody debris. (Photographer: J. Melsted, Catalogue No: RHIP03LYX019)

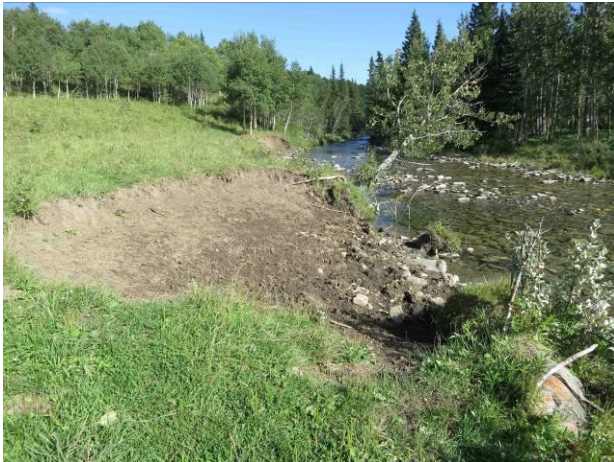
A livestock watering access point along Pekisko Creek with erosion and bare soil concerns. Installing an off-stream water trough could allow this portion of the bank to naturally revegetate. (Photographer: K. Hull, Catalogue No: RHIP15PEK020)

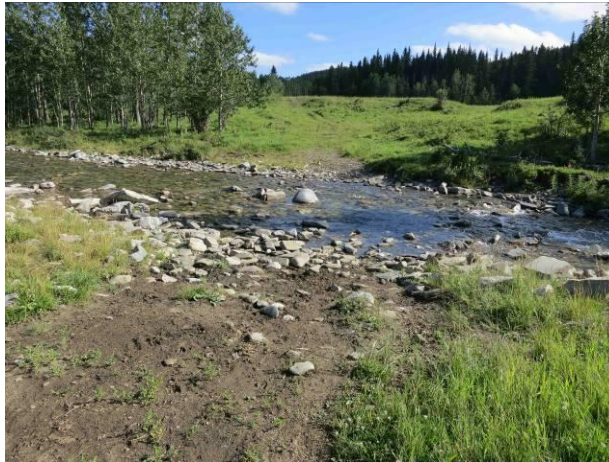
This vehicle crossing along Pekisko Creek presently receives low amounts of use as general public access is restricted. Ongoing monitoring of weeds and erosion is suggested here. If erosion and bare soil concerns worsen, bridge installation or other crossing measures may be appropriate. (Photographer: K. Hull, Catalogue No: RHIP15PEK020)

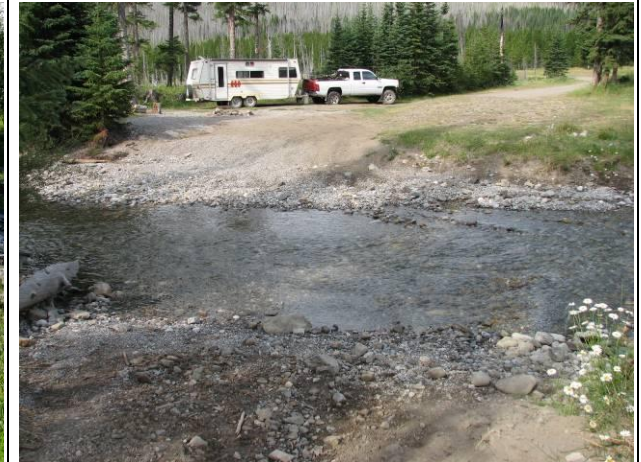
Recreational trails and roads contribute to soil compaction and sedimentation concerns in the project area, including at this Lynx Creek site. (Photographer: J. Melsted, Catalogue No: RHIP03LYX010)

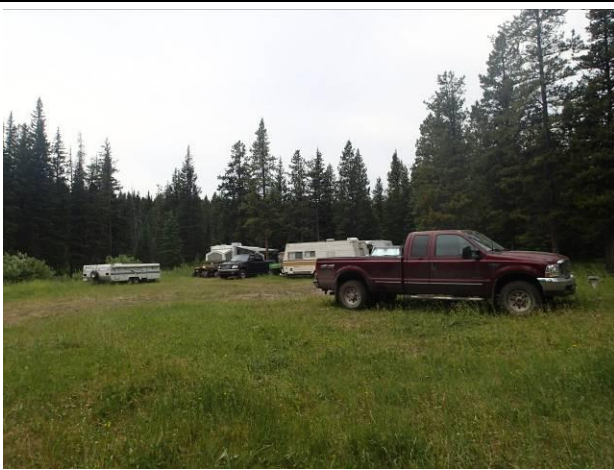
Random camping is a major contributor to soil compaction, bare ground and native vegetation disturbance in the meadows in the Dutch Creek valley. (Photographer: J. Melsted, Catalogue No: RHIP01DUT007)

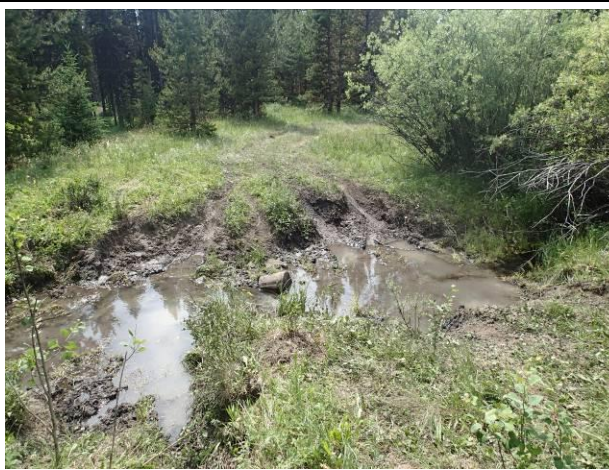
All terrain vehicle trail rutting, soil compaction and erosion along a tributary of Dutch Creek. (Photographer: J. Melsted, Catalogue No: RHIP01DUT011)

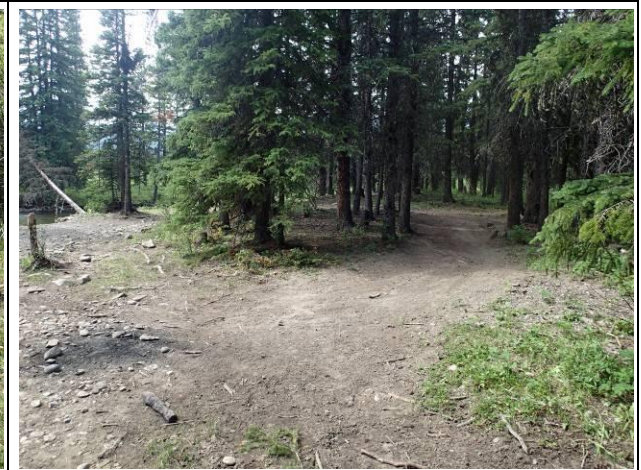
Human-caused bare ground is a concern along portions of numerous streams, such as Dutch Creek, with recreational use impacts such as all-terrain vehicle trails. (Photographer: J. Melsted, Catalogue No: RHIP01DUT015)

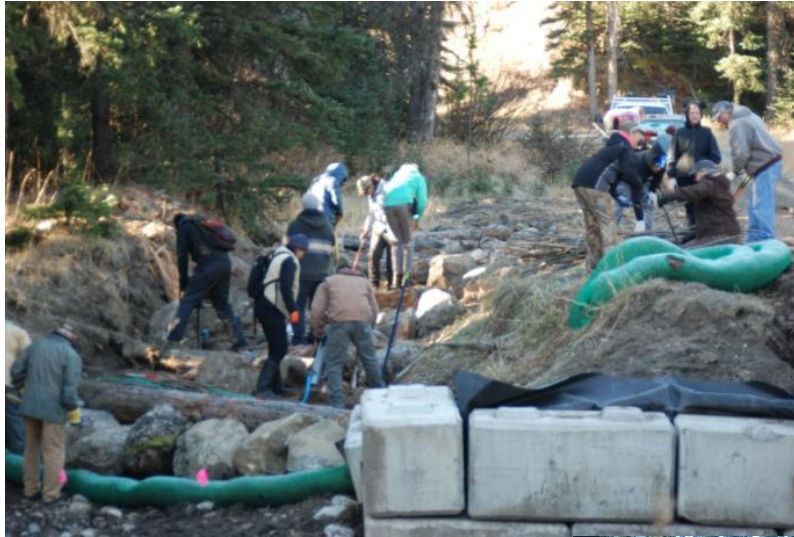
Dutch Creek restoration October 2015. This was a collaborative effort with the Oldman Watershed Council and involved input from Spray Lake Sawmills, Crowsnest Pass Quad Squad and many (47) volunteers.

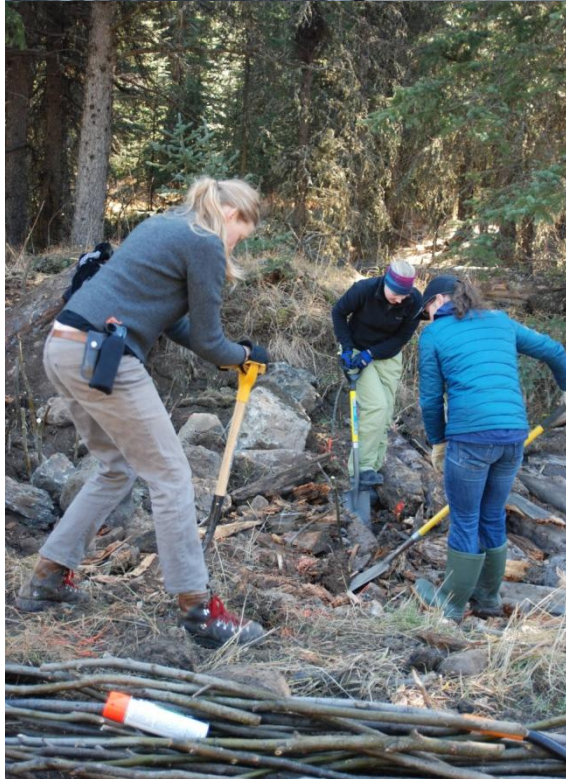
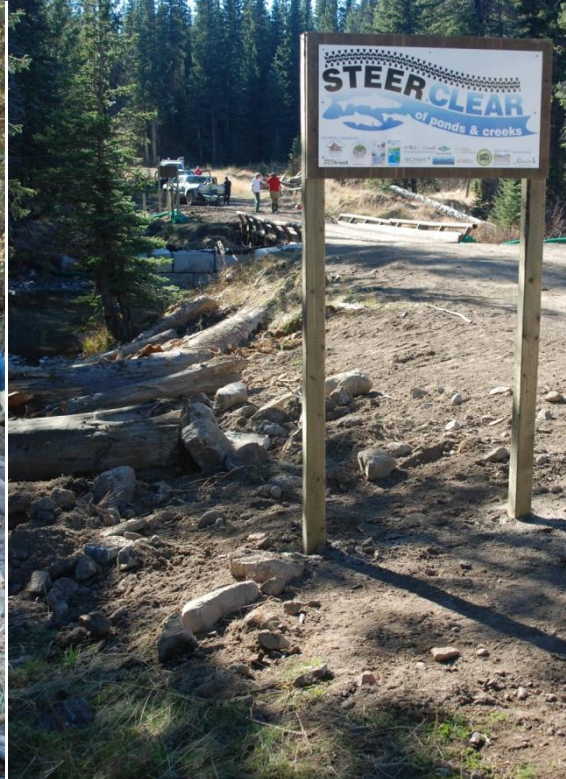
Dutch Creek (DUT2) riparian planting and restoration project – October 27, 2015. Balsam poplar, willow and red-osier dogwood live stakes were installed along with fencing and prominent signage to prevent OHVs from fording through the creek.

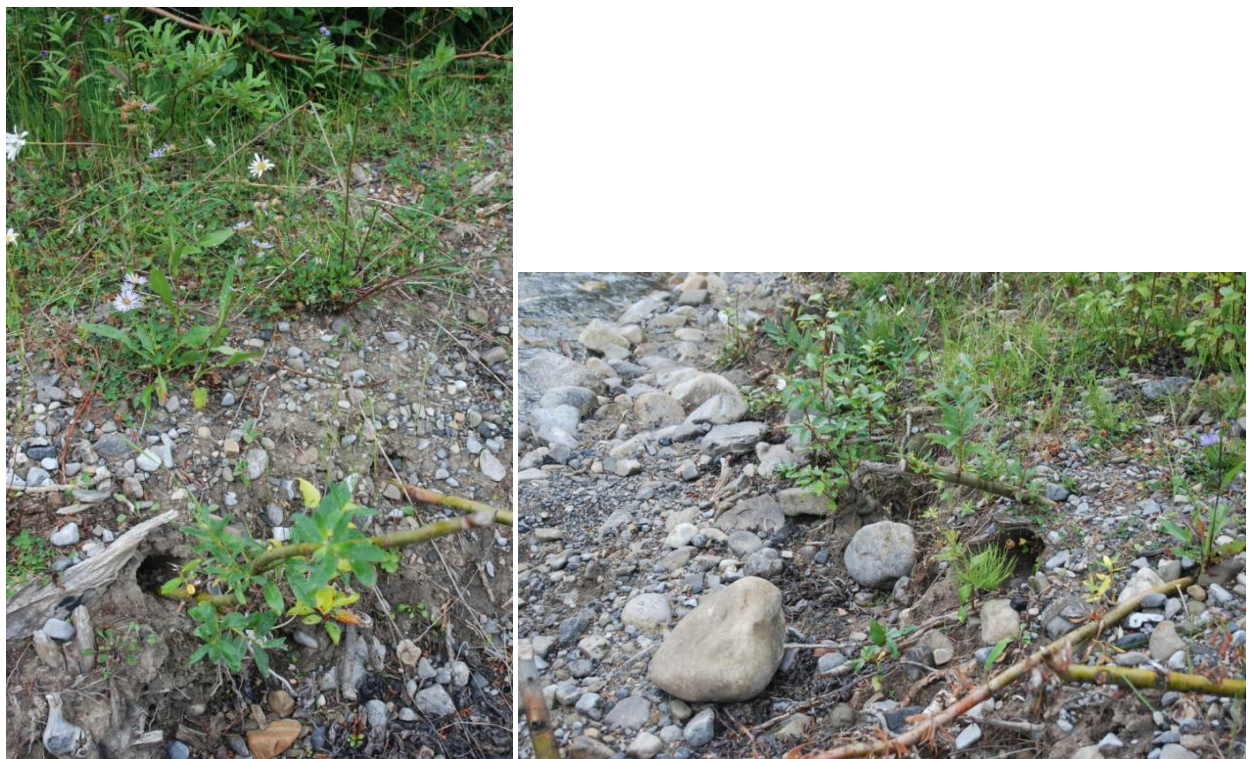
Subsequent return to the 2013 Allison Creek site (shown above) in August 2014 showed successful growth of live willow stakes along the banks.

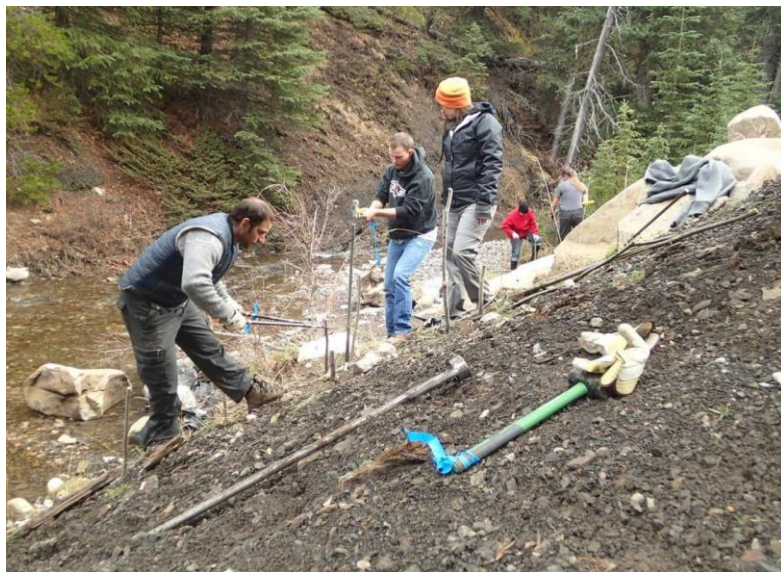
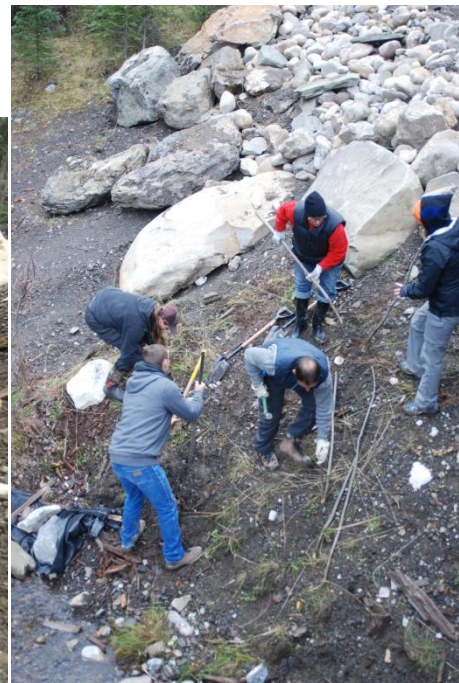
Smith Creek (SMT2) riparian planting project, October 24, 2014. Live willow and balsam poplar stakes were installed on the steep approach slopes adjacent to the quad bridge to help stabilize and reduce bank erosion.

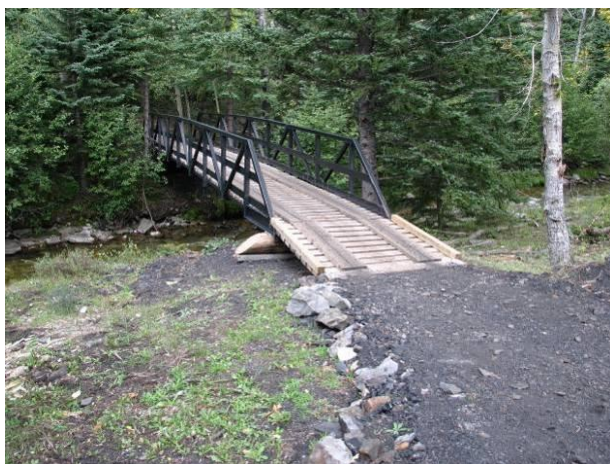
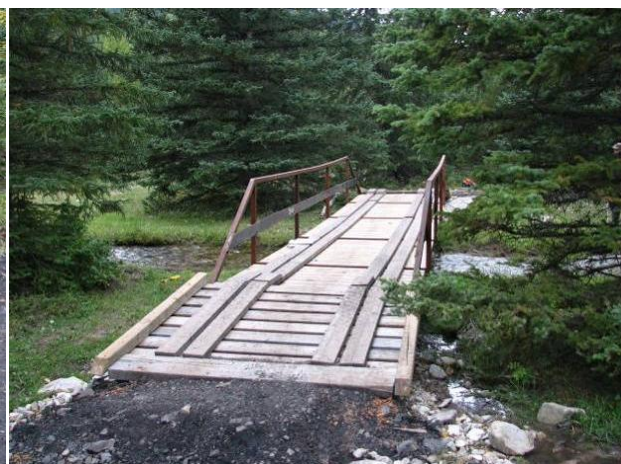
New bridges were installed along Gold Creek (left) and Green Creek (Right) by the Crowsnest Pass Quad Squad to prevent continued fording of the creek.
