# SUMMARY REPORT

**Water Quality Improvements Through  
Riparian Health and Grazing  
Management Changes**

**Lake Winnipeg Basin Project (LWBP) 2024-  
2026**

Report No. 060

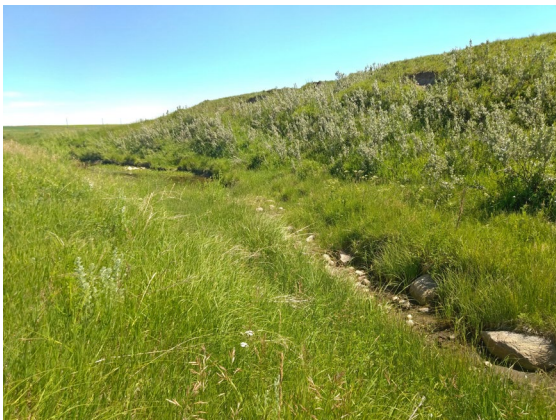
**LON1.** Riparian Health Inventory was completed at four stream sites in the Rosebud River watershed as part of this project including Lone Pine Creek, pictured here. *(Photo: RHIP01LON006)*

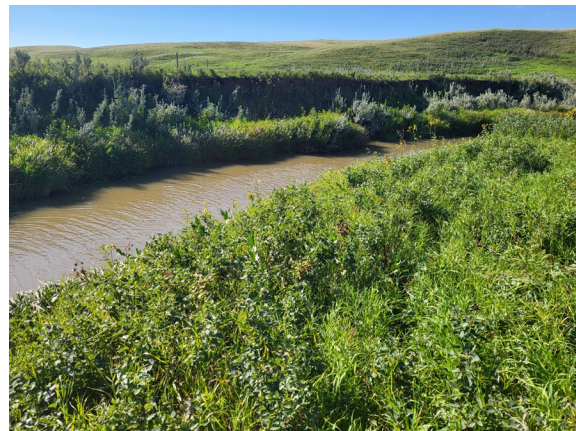
**CRO39.** A diversity of shrubs line the streambank, providing deep binding roots to protect against erosion at this Crowfoot Creek site included as one of the Riparian Health Inventory sites. *(Photo: RHIP36CRO012)*

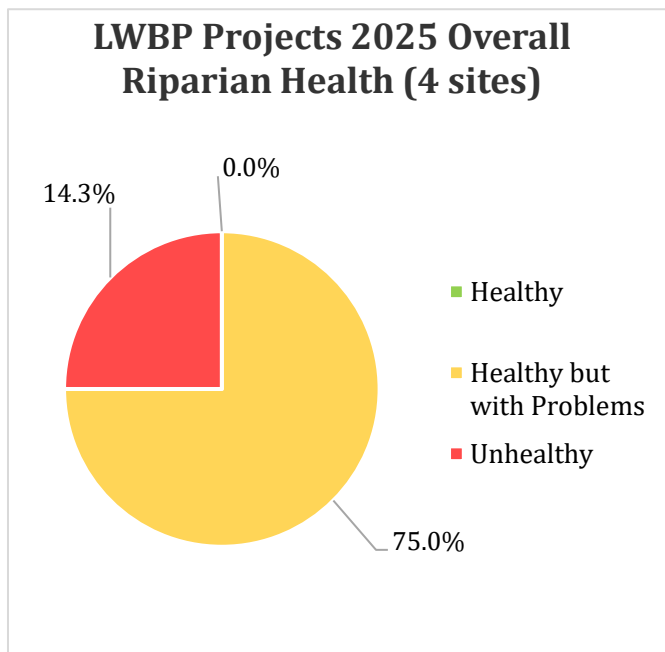
**Figure 1 Riparian Health Inventory Score Results for 4 LWBP Project Sites (2025)**

The following is a summary of the information from the baseline riparian health of four sites (CRO35, CRO39, LON1, TE11) included in the project based on data collected in 2025. Information obtained from the Riparian Health Inventory of these sites helped inform and facilitate management planning and encouraged private landowners to understand and improve management of riparian areas under their care.

Overall, of the 4 sites, no sites rated *healthy* (0%), three sites (75%) were *healthy but with problems*, and one site (25%) was *unhealthy* as shown in Figure 1 and Table 1.

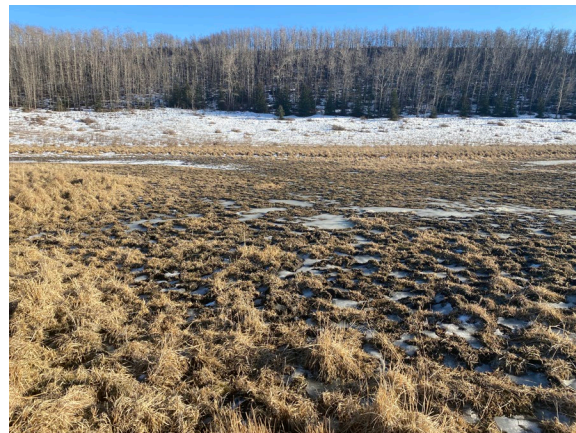
**DEMOGRAZ100.** Example of bank alterations (pugs and hummocks) due to livestock impacts that changes in cattle management (e.g. fencing) can help alleviate (Photo: DEMO100GRAZ0006)

This project involved the planning and purchase of materials to construct approximately 2,150 meters of riparian exclusion fence along Carstairs Creek to exclude 25 cow/calf pairs from grazing within the riparian area. Approximately 1.4 km of stream length along Carstairs Creek will be protected and 6.3 hectares of riparian habitat. Materials have been purchased for a 4-strand high tensile electric fencing at wildlife friendly heights to encompass Carstairs Creek to be installed prior to grazing starting. The site currently has a perpetual conservation easement on the uplands and riparian habitat with Legacy Land Trust Society on approximately 45 hectares of pastureland. Some tree planting in the riparian area has occurred in the past. Historically, the site has been summer grazed with livestock watering from the creek.

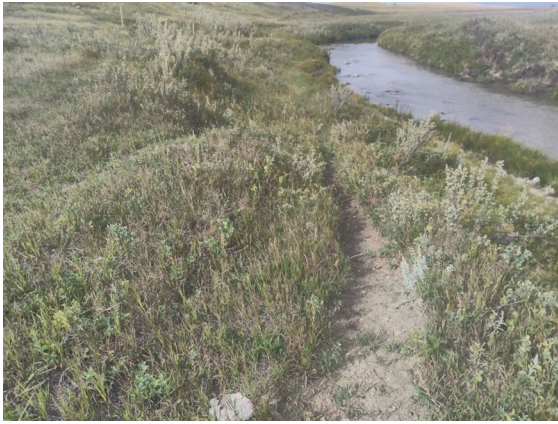
**CRO39\_2021.** A livestock trail present along the banks of Crowfoot Creek resulting in bare soil and compaction. Photo taken in 2021 during a riparian health inventory after the addition of alternative livestock watering and some partial exclusion fencing. This demonstrates the long-term commitment of this landowner to make continued changes to riparian management and monitor success. *(Photo: RHIP34CRO015)*

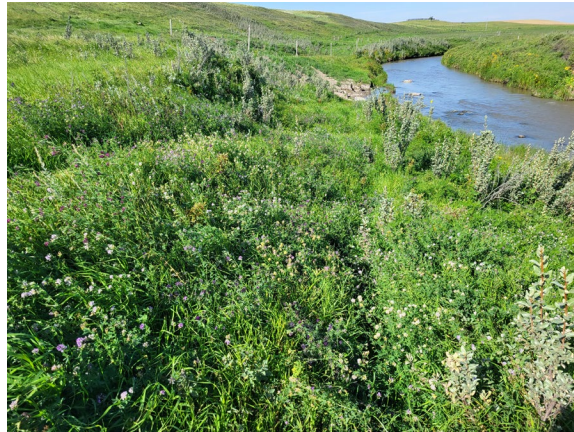
**CRO39\_2025.** Since the 2021 photo was captured (image to the left), the livestock trail has revegetated. In addition to earlier management changes at this site, including livestock exclusion fencing and alternative watering options, a new elevated bridge crossing is in place to allow access for livestock to pastures on both sides of the creek and prevent stream channel and bank impacts. *(Photo: RHIP39CRO017)*

Riparian health inventories were completed in 2025 at a site previously inventoried by Cows and Fish in 2021 (CRO39) where we were able to capture photo monitoring data to demonstrate health trends. In addition, a baseline riparian health inventory was completed adjacent to the new elevated crossing location (CRO35). Individual site reports summarizing the riparian health inventories were completed to provide the landowner and project partners with a summary of riparian health and note any trends associated with our photo monitoring of the 2021 site. The project was completed in partnership with the landowner, Wheatland County, and Cows and Fish.
