# **2014 Riparian Health Inventory Project (Year 4): Westslope Cutthroat Trout Priority Streams**

*A Summary of the Riparian Health Status and Habitat Improvement Needs for  
14 Priority Westslope Cutthroat Trout Sites in the South Eastern Slopes of Alberta*

Alberta Riparian Habitat Management Society (Cows and Fish)  
Report No. 044

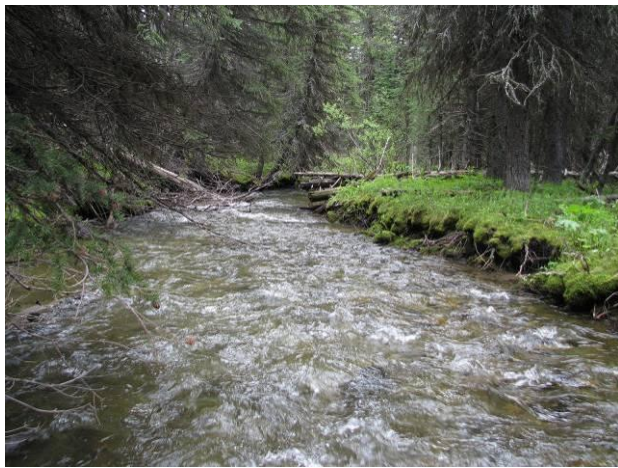
**Photo a:** An example of the dominant tree community type in the project area, a White Spruce / Common Horsetail community. Although it has little palatable forage for livestock, this native plant community has high fish and wildlife habitat value. (Photographer: A. Sarrazin, Catalogue No: RHIP01NRC017)

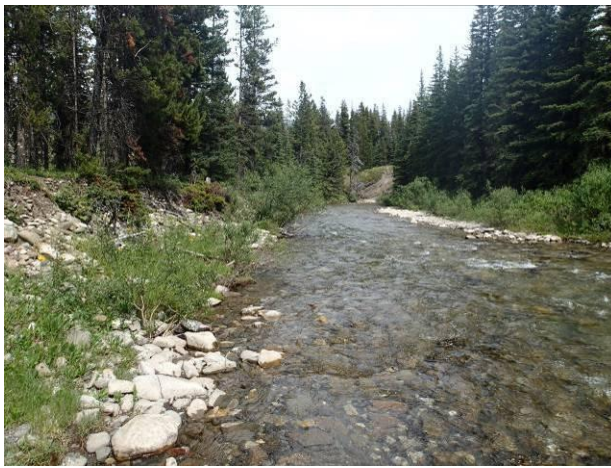
**Photo b:** A Lodgepole Pine / Common Bearberry - Juniper community is associated with south exposures and coarse-textured soils on the south bank of Dutch Creek (to the left). White spruce and willow types occur on north exposures and moist streambank or point bar features of this creek (to the right). (Photographer: J. Melsted, Catalogue No: RHIP01DUT017)

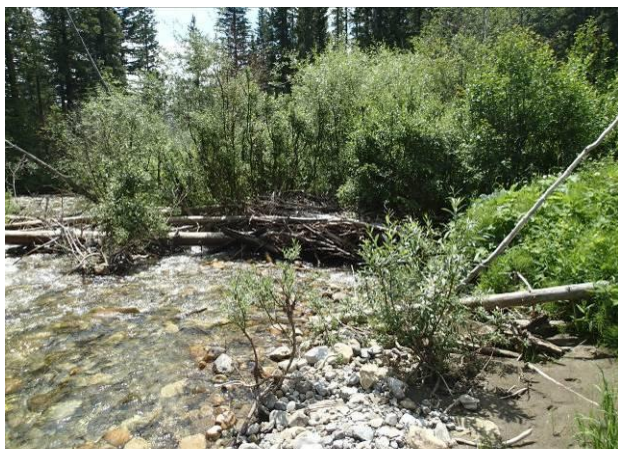
**Photo d:** Drummond's Willow is commonly occurring in the project area where it forms dense, tall stands along the streambank. (Photographer: A. Sarrazin, Catalogue No: RHIP03ALL004)

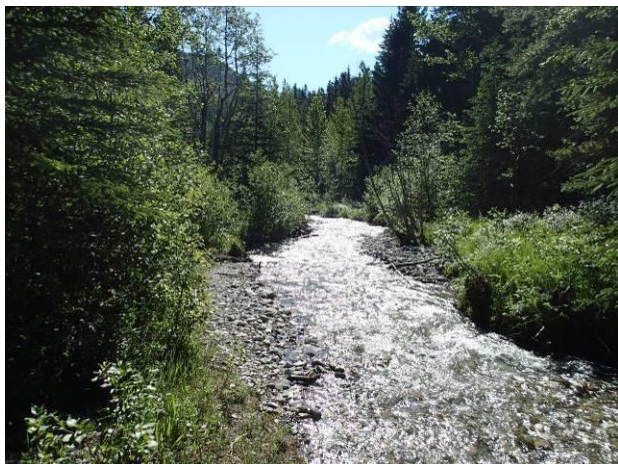
**Photo f:** Dense native tree and shrub communities along this reach of Star Creek (STA1) provide high amounts of ground stabilization and cover and sheltering habitat for fish and wildlife. (Photographer: J. Melsted, Catalogue No: RHIP01STA008)

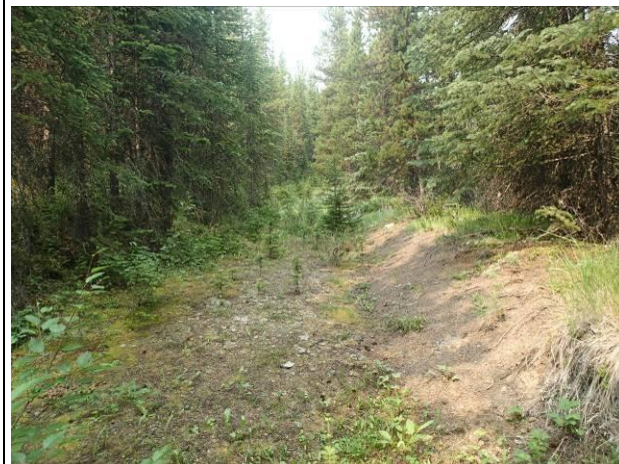
**Photo h:** Natural regeneration of native trees and shrubs is occurring along this old access road on the north side of Vicary Creek. Continuing to minimize human-caused disturbance here will help ensure successful vegetation establishment, benefitting reduced erosion. (Photographer: J. Melsted, Catalogue No: RHIP01VIC015)

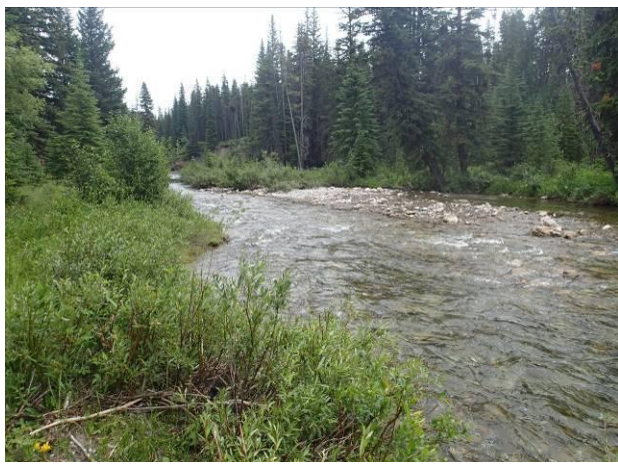
- Most sites have healthy amounts of native tree and shrub regeneration (**Photo i**, page 18), except for ratings of 4/6 for GOL2, GOL3, SHA3, TRO1 and VIC1. These sites have 5% to 15% canopy cover from seedling or sapling preferred trees and shrubs.
- The SMT2 stream crossing reach rated 2/6 for regeneration, indicating that there is less than 5% canopy cover here from seedling or sapling preferred trees and shrubs. Riparian planting was done at SMT2 in the fall of 2014 (after the riparian health inventory was conducted).
- Of note, riparian plantings done in the fall of 2013 in the ALL3 site could not yet be counted toward seedling or sapling cover. Human plantings need to have survived for at least one full growing season before they can be counted as successfully established.

**Photo i:** There is abundant cover from seedling and sapling aged willows, native shrubs and white spruce along Dutch Creek (DUT1) (Photographer: J. Melsted, Catalogue No: RHIP01DUT009)

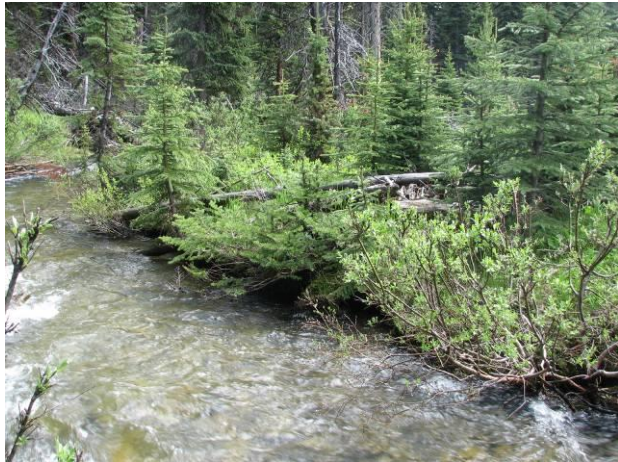
**Photo l:** This reach of North Racehorse Creek has high amounts of root mass protection from a combination of willows, spruce and sedges (Photographer: A. Sarrazin, Catalogue No: RHIP01NRC003)

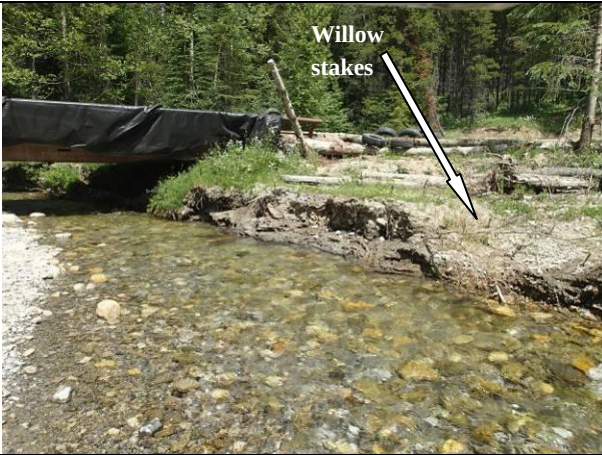
FORDED STREAM CROSSING LEFT BANK  
DOWNSTREAM OF TEMPORARY LOGGING BRIDGE  
(Photographer: A. Sarrazin, Catalogue No: RHIP03ALL008)

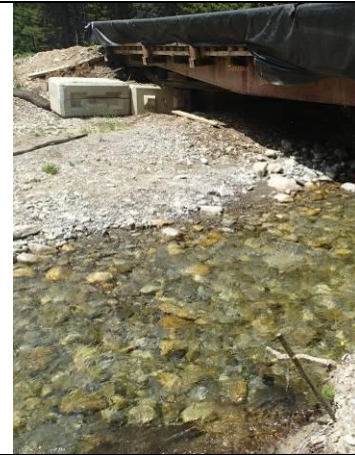
FORDED STREAM CROSSING RIGHT BANK  
DOWNSTREAM OF TEMPORARY LOGGING BRIDGE  
(Photographer: A. Sarrazin, Catalogue No: RHIP03ALL007)

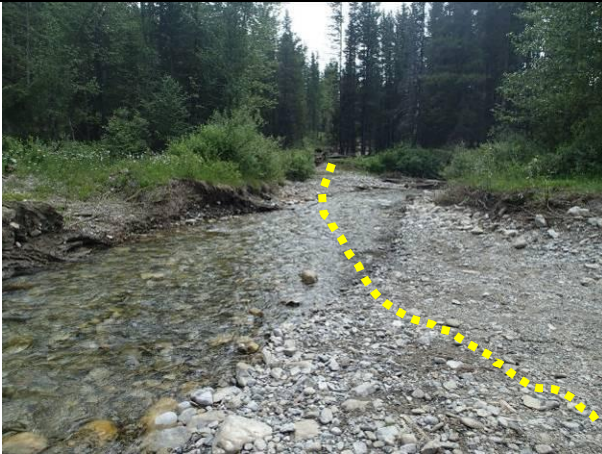
FORDED STREAM CROSSING (YELLOW-DASHED  
LINE)VIEW DOWNSTREAM, DOWNSTREAM OF  
TEMPORARY LOGGING BRIDGE (Photographer: A.  
Sarrazin, Catalogue No: RHIP03ALL009)

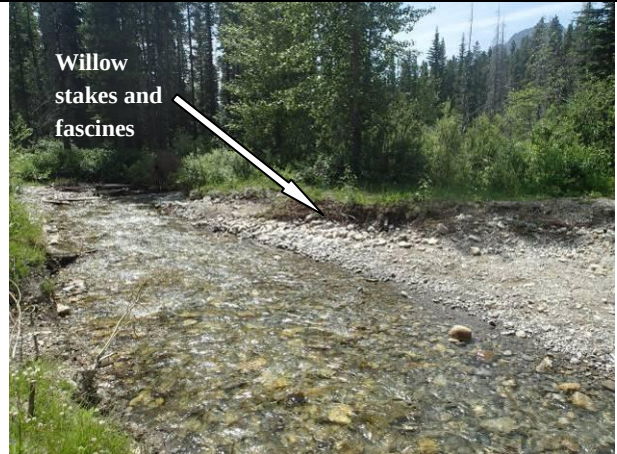
FORDED STREAM CROSSING VIEW TO RIGHT BANK  
DOWNSTREAM OF TEMPORARY LOGGING BRIDGE  
(Photographer: A. Sarrazin, Catalogue No: RHIP03ALL010)

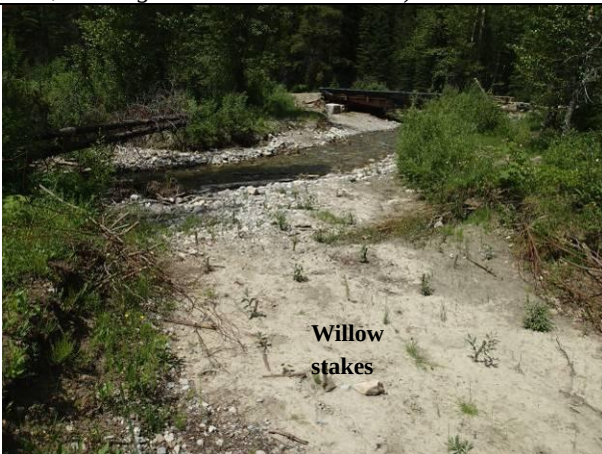
WILLOW PLANTINGS IN FOREGROUND, VIEW  
UPSTREAM TO TEMPORARY LOGGING BRIDGE  
(Photographer: A. Sarrazin, Catalogue No: RHIP03ALL002)

**NOTE:** There is a recently installed quad bridge immediately upstream of the logging bridge (not visible in the above photos). Willow stakes shown here were installed in November 2013 as part of a volunteer event led by Cows and Fish.

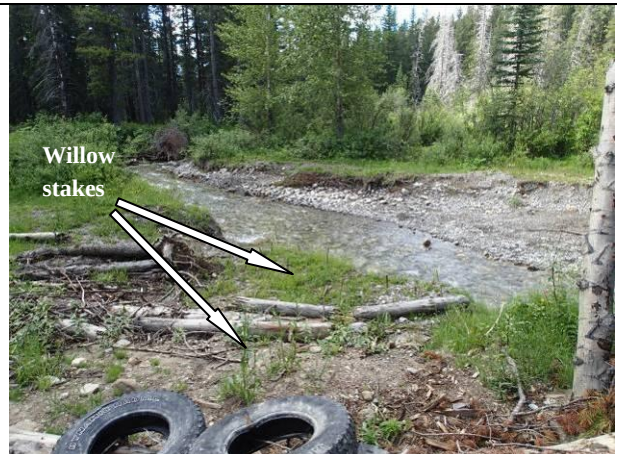
WILLOW PLANTINGS IN FOREGROUND NEAR TIRES,  
ADJACENT TO TEMPORARAY LOGGING BRIDGE  
(Photographer: A. Sarrazin, Catalogue No: RHIP03ALL012)

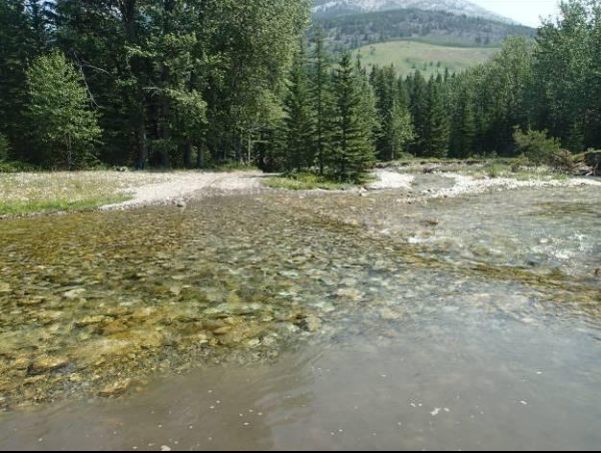
FORDED STREAM CROSSING LEFT BANK  
(Photographer: J. Melsted, Catalogue No: RHIP02GOL005)

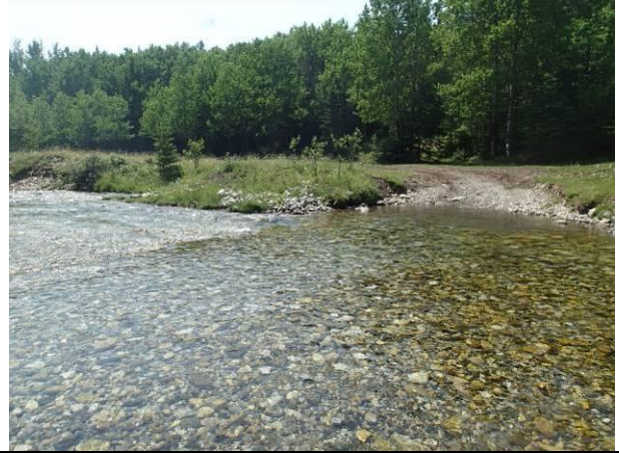
FORDED STREAM CROSSING RIGHT BANK  
(Photographer: J. Melsted, Catalogue No: RHIP02GOL006)

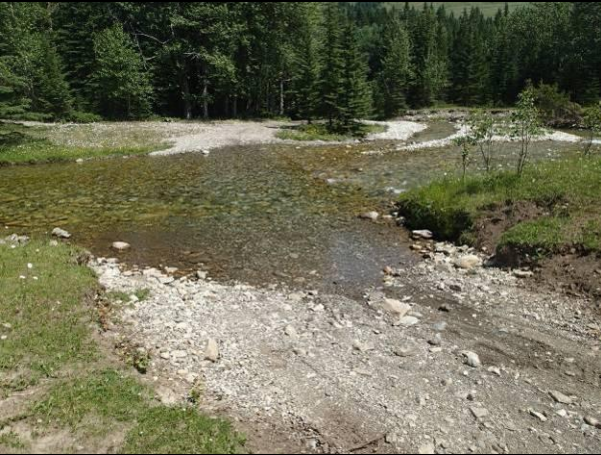
FORDED STREAM CROSSING (VIEW FROM RIGHT BANK TO LEFT BANK)  
(Photographer: J. Melsted, Catalogue No: RHIP02GOL009)

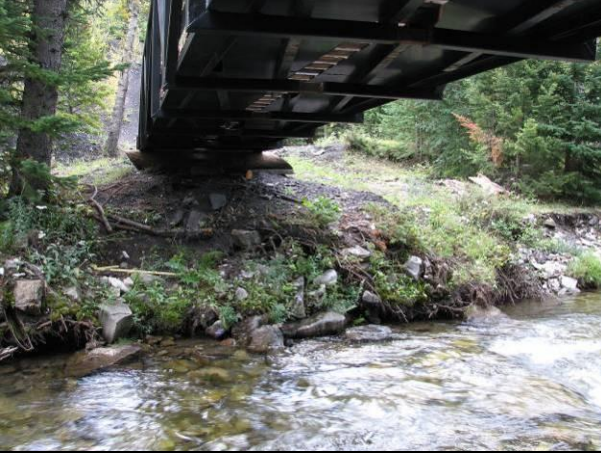
LEFT BANK, AT NEW QUAD BRIDGE CROSSING  
(Photographer: J. Melsted, Catalogue No: RHIP03GOL005)

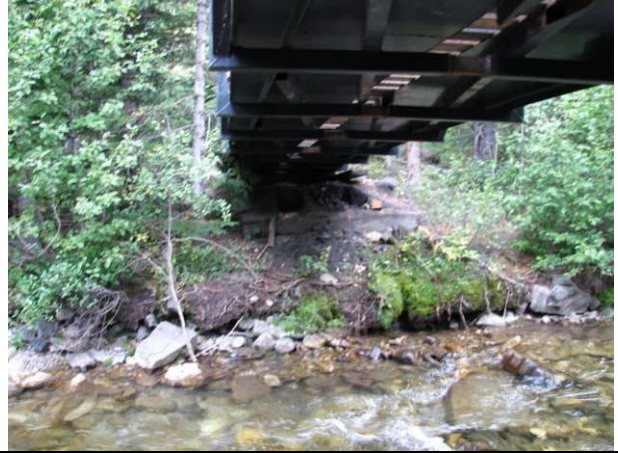
RIGHT BANK, AT NEW QUAD BRIDGE CROSSING  
(Photographer: J. Melsted, Catalogue No: RHIP03GOL006)

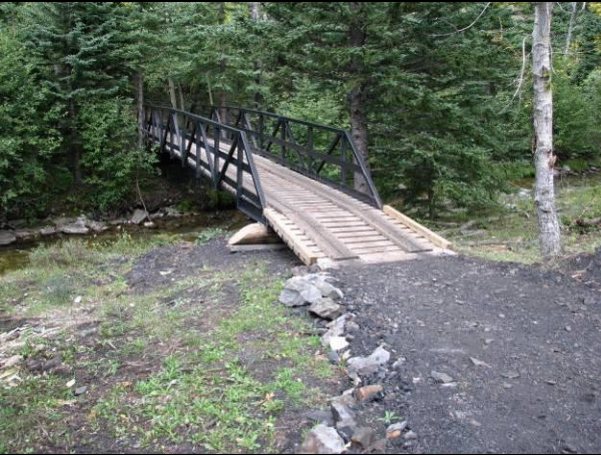
NEW QUAD BRIDGE APPROACH (VIEW FROM LEFT BANK TO RIGHT BANK)  
(Photographer: J. Melsted, Catalogue No: RHIP03GOL010)

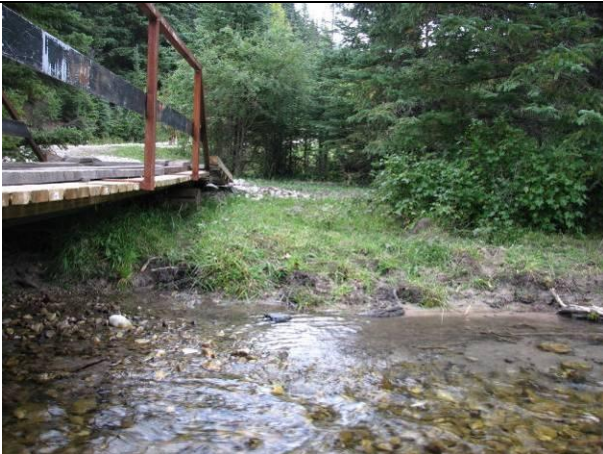
LEFT BANK, AT NEW QUAD BRIDGE CROSSING  
(Photographer: M. Plemel, Catalogue No: RHIP01GRE008)

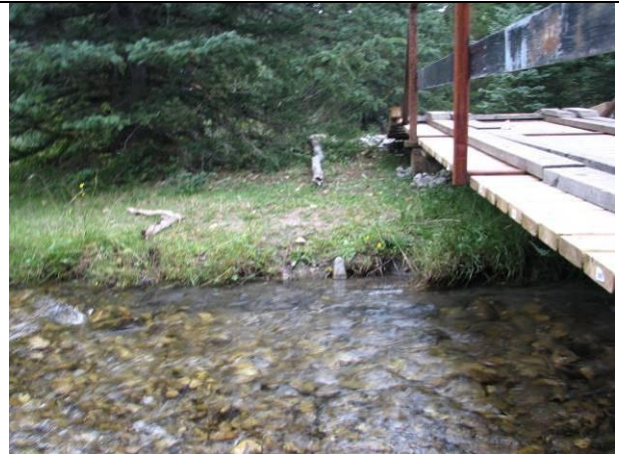
RIGHT BANK, AT NEW QUAD BRIDGE CROSSING  
(Photographer: M. Plemel, Catalogue No: RHIP01GRE009)

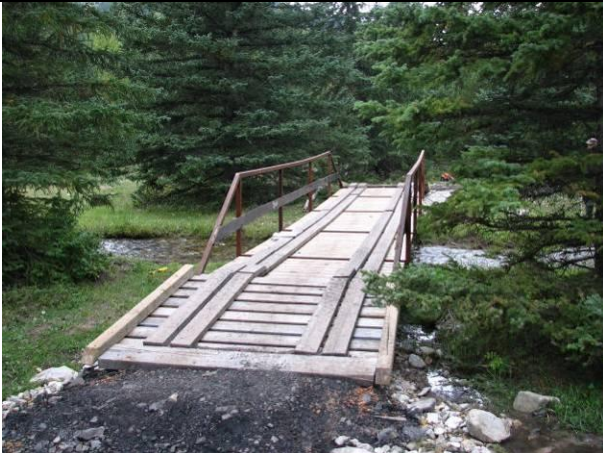
NEW QUAD BRIDGE APPROACH (VIEW FROM LEFT BANK TO RIGHT BANK)  
(Photographer: M. Plemel, Catalogue No: RHIP01GRE006)

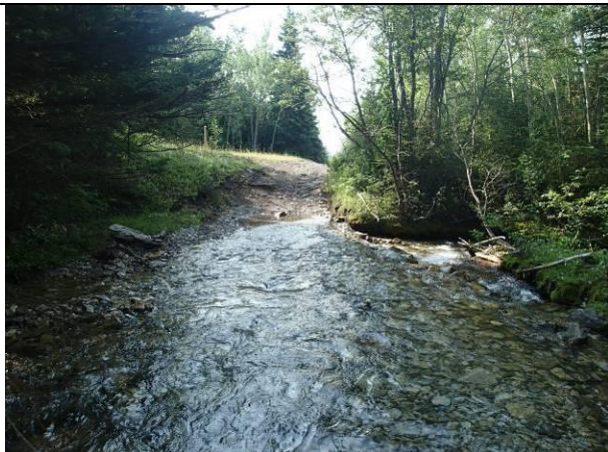
**FORDED STREAM CROSSING LEFT BANK**  
(Photographer: A. Sarrazin, Catalogue No: RHIP01MOR007)

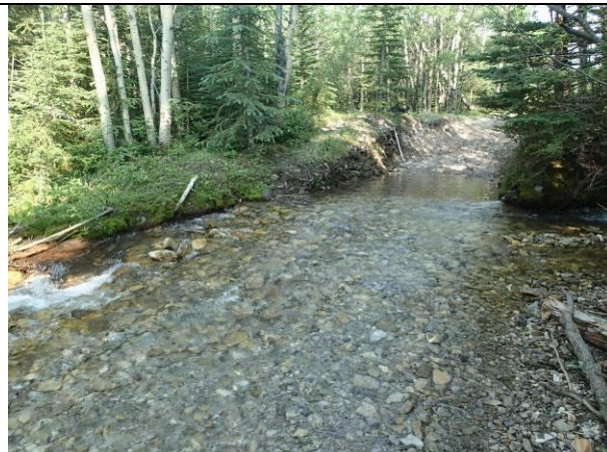
**FORDED STREAM CROSSING RIGHT BANK**  
(Photographer: A. Sarrazin, Catalogue No: RHIP01MOR008)

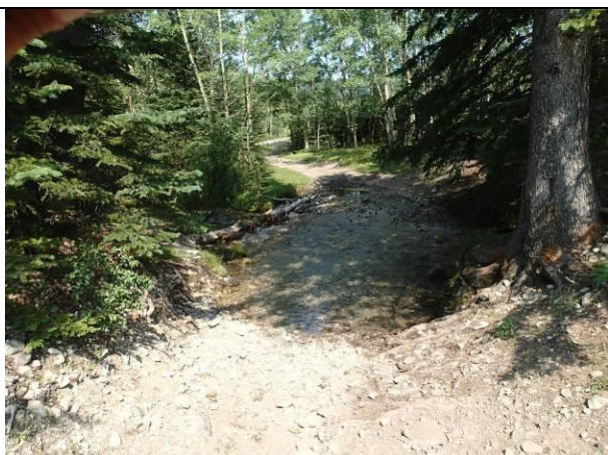
**FORDED STREAM CROSSING VIEW FROM LEFT BANK TO RIGHT BANK**  
(Photographer: A. Sarrazin, Catalogue No: RHIP01MOR009)

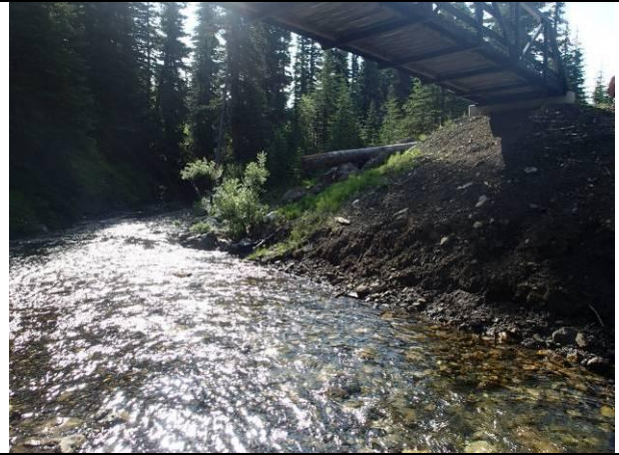
**STREAM CROSSING LEFT BANK**

Rip rap has been placed to prevent erosion where there was formerly a forded crossing, downstream of the new quad bridge. (Photographer: J. Melsted, Catalogue No: RHIP02SMT009)

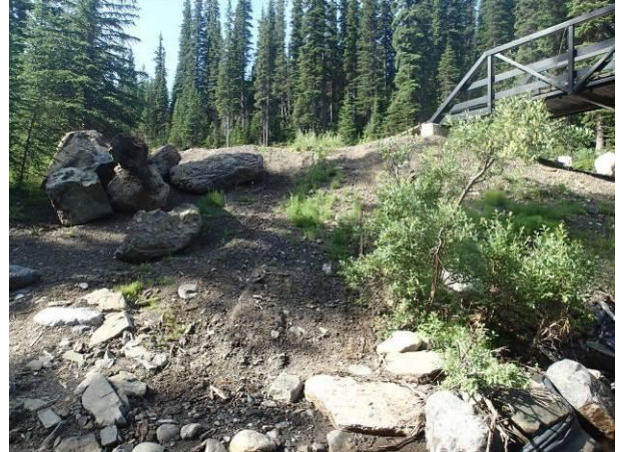
**STREAM CROSSING LEFT BANK.**

Damaged silt fence, approach slope erosion and recent evidence of stream fording. (Photographer: J. Melsted, Catalogue No: RHIP02SMT013)

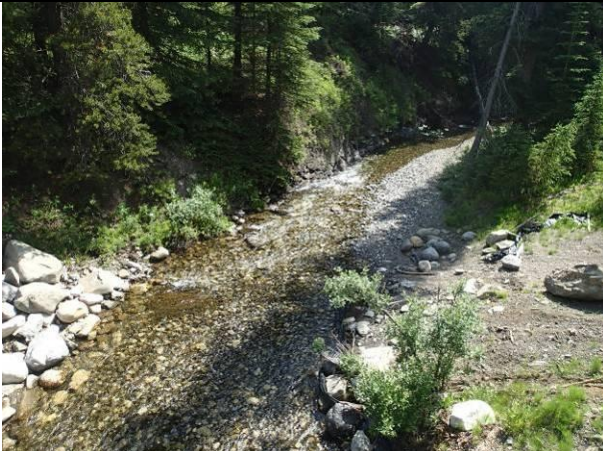
**STREAM CROSSING RIGHT BANK**

Logs and boulders were originally placed to prevent fording of the creek and encourage use of the bridge. These obstructions have since been moved away, allowing fording use to continue. (Photographer: J. Melsted, Catalogue No: RHIP02SMT012)
