Is My Crick Sick? Is My Lakeshore Lame?

Here are several riparian health examples to help you tune your eye.

Lake and Wetland Health Assessments

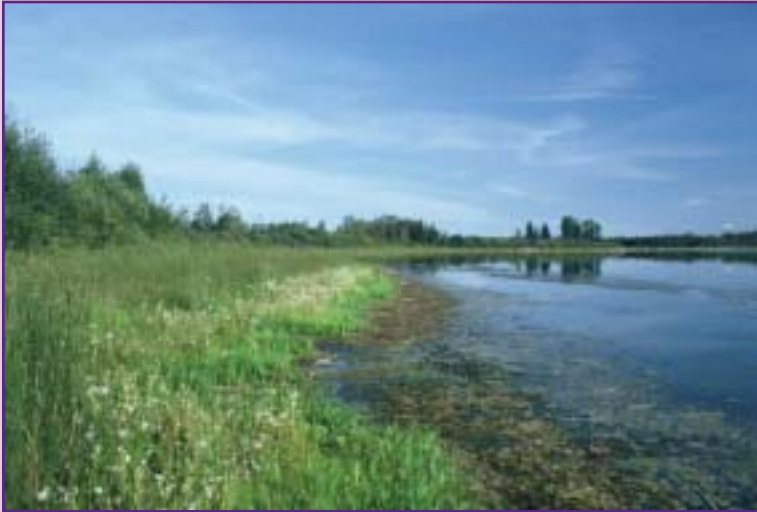
vegetation cover	<u>6/6</u>
invasive weeds	<u>0/6</u>
disturbance species	<u>3/3</u>
woody regeneration	<u>6/6</u>
wood utilization	<u>2/3</u>
vegetation alteration	<u>6/6</u>
site alteration	<u>12/12</u>
bare ground	<u>6/6</u>
water manipulation	<u>9/9</u>

TOTAL: 50/57 = **88%**

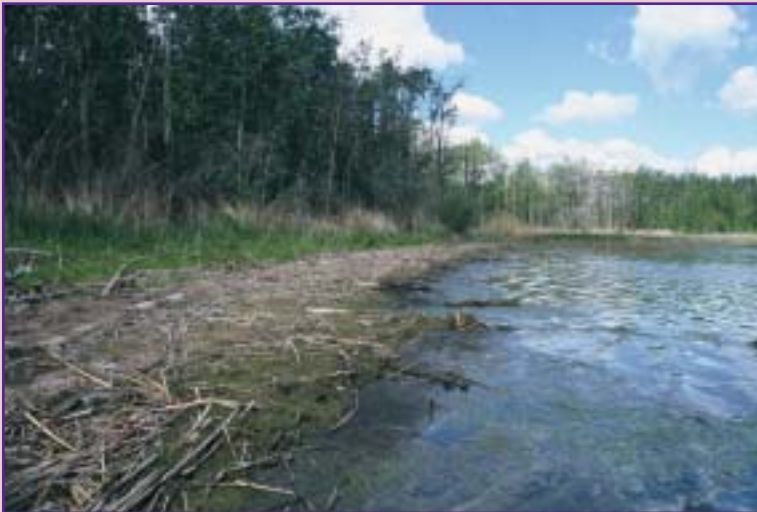
vegetation cover	<u>6/6</u>
invasive weeds	<u>2/6</u>
disturbance species	<u>1/3</u>
woody regeneration	<u>4/6</u>
wood utilization	<u>2/3</u>
vegetation alteration	<u>4/6</u>
site alteration	<u>8/12</u>
bare ground	<u>6/6</u>
water manipulation	<u>9/9</u>

TOTAL: 42/57 = **74%**

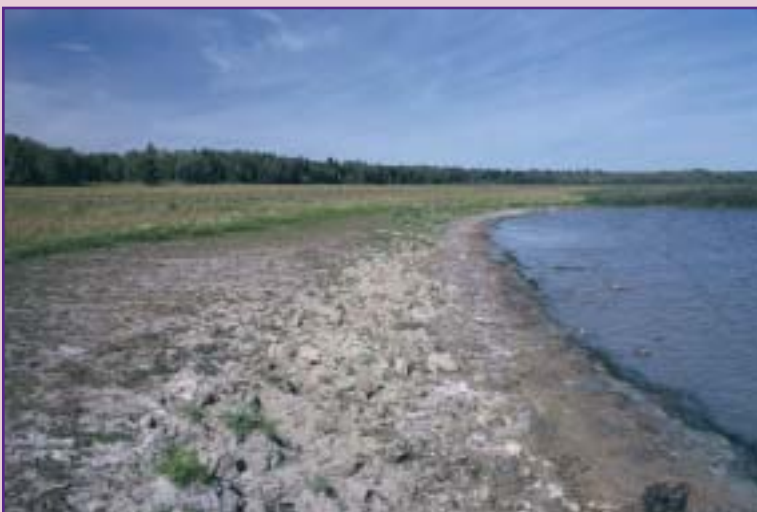
vegetation cover	<u>4/6</u>
invasive weeds	<u>0/6</u>
disturbance species	<u>2/3</u>
woody regeneration	<u>6/6</u>
wood utilization	<u>0/3</u>
vegetation alteration	<u>2/6</u>
site alteration	<u>4/12</u>
bare ground	<u>4/6</u>
water manipulation	<u>6/9</u>

TOTAL: 28/57 = **49%**

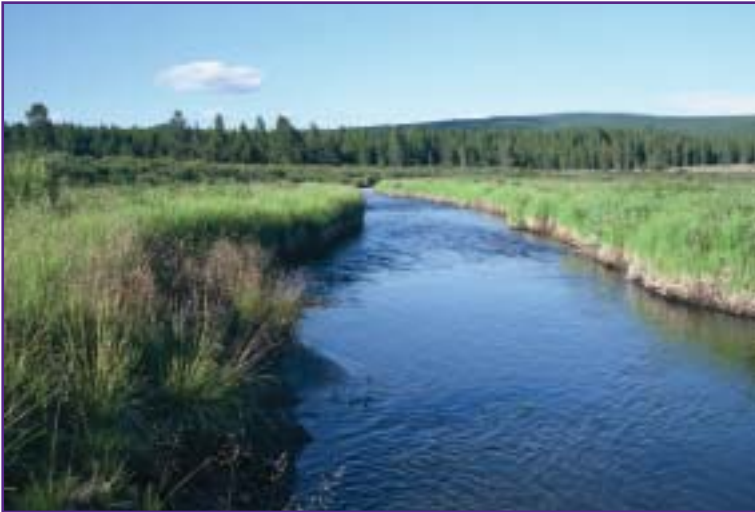
vegetation cover	<u>6/6</u>
invasive weeds	<u>6/6</u>
disturbance species	<u>2/3</u>
woody regeneration	<u>6/6</u>
wood utilization	<u>1/3</u>
dead wood	<u>3/3</u>
root mass / deep roots	<u>6/6</u>
bare ground	<u>6/6</u>
site alteration	<u>6/6</u>
compaction	<u>3/3</u>
floodplain accessible	<u>9/9</u>

TOTAL: 54/57 = **95%**

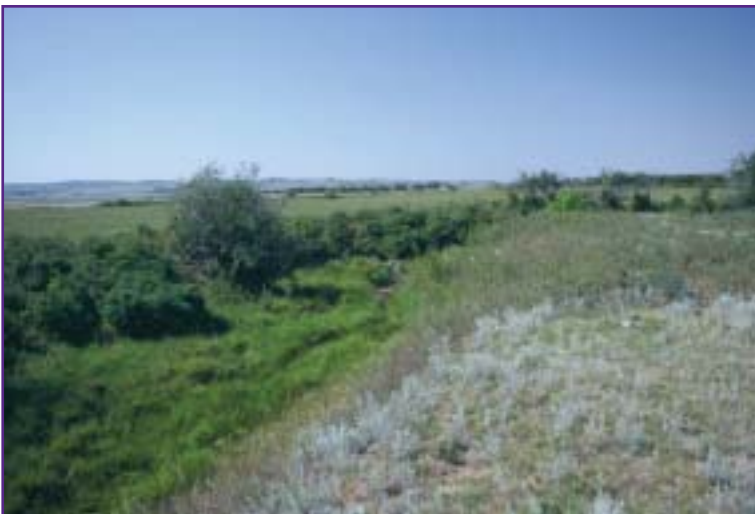
vegetation cover	<u>6/6</u>
invasive weeds	<u>4/6</u>
disturbance species	<u>0/3</u>
woody regeneration	<u>4/6</u>
wood utilization	<u>0/3</u>
dead wood	<u>3/3</u>
root mass / deep roots	<u>4/6</u>
bare ground	<u>2/6</u>
site alteration	<u>6/6</u>
compaction	<u>1/3</u>
floodplain accessible	<u>6/9</u>

TOTAL: 36/57 = **63%**

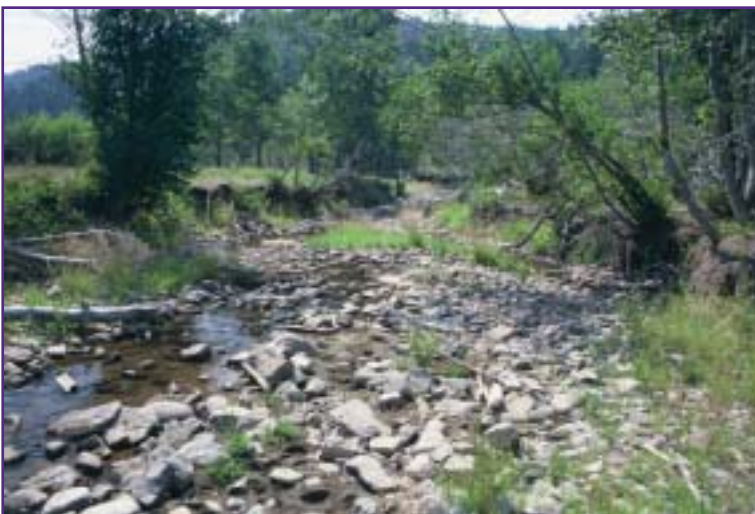
vegetation cover	<u>6/6</u>
invasive weeds	<u>0/6</u>
disturbance species	<u>0/3</u>
woody regeneration	<u>2/6</u>
wood utilization	<u>0/3</u>
dead wood	<u>3/3</u>
root mass / deep roots	<u>2/6</u>
bare ground	<u>4/6</u>
site alteration	<u>2/6</u>
compaction	<u>2/3</u>
floodplain accessible	<u>6/9</u>

TOTAL: 27/57 = **47%**

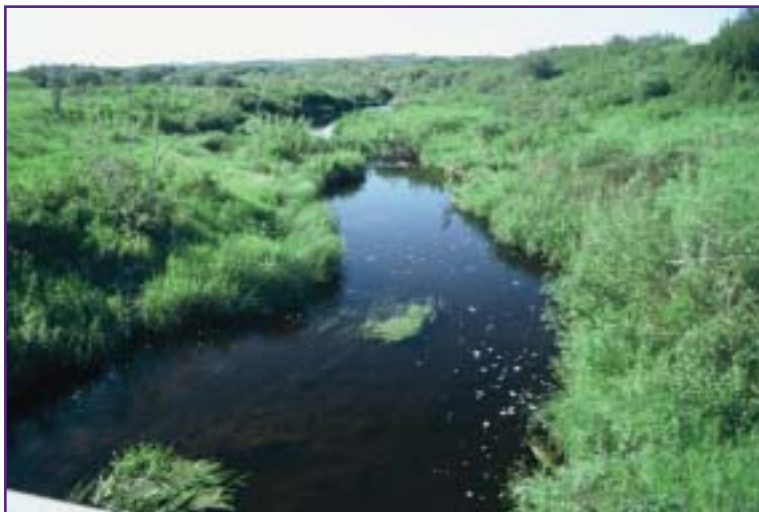
vegetation cover	<u>6/6</u>
invasive weeds	<u>0/6</u>
disturbance species	<u>0/3</u>
woody regeneration	<u>6/6</u>
wood utilization	<u>2/3</u>
dead wood	<u>3/3</u>
root mass / deep roots	<u>6/6</u>
bare ground	<u>6/6</u>
site alteration	<u>6/6</u>
compaction	<u>3/3</u>
floodplain accessible	<u>9/9</u>

TOTAL: 47/57 = **82%**

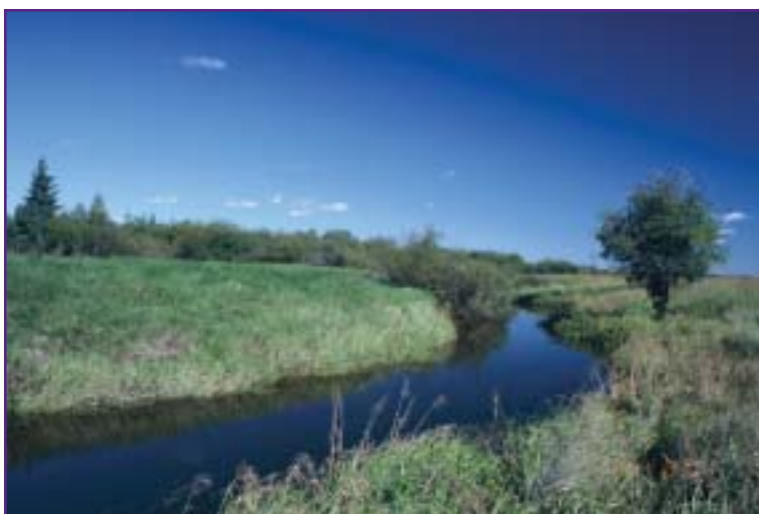
vegetation cover	<u>6/6</u>
invasive weeds	<u>0/6</u>
disturbance species	<u>1/3</u>
woody regeneration	<u>4/6</u>
wood utilization	<u>2/3</u>
dead wood	<u>3/3</u>
root mass / deep roots	<u>4/6</u>
bare ground	<u>4/6</u>
site alteration	<u>6/6</u>
compaction	<u>1/3</u>
floodplain accessible	<u>6/9</u>

TOTAL: 37/57 = **65%**

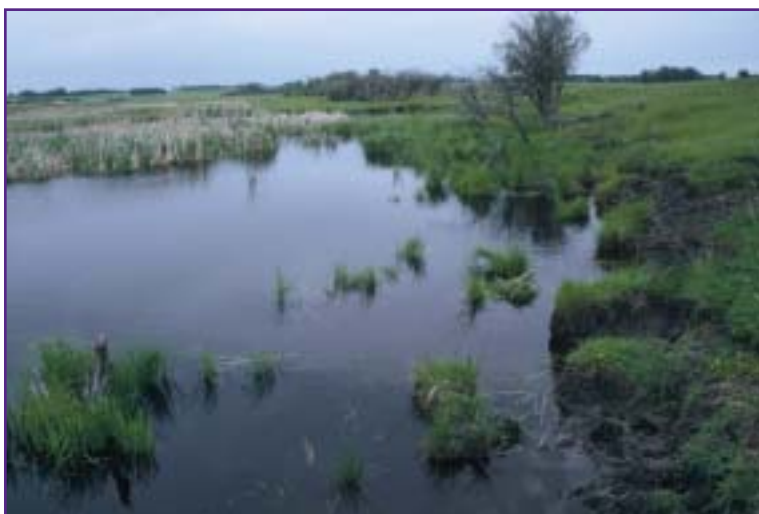
vegetation cover	<u>4/6</u>
invasive weeds	<u>4/6</u>
disturbance species	<u>1/3</u>
woody regeneration	<u>2/6</u>
wood utilization	<u>0/3</u>
dead wood	<u>2/3</u>
root mass / deep roots	<u>4/6</u>
bare ground	<u>2/6</u>
site alteration	<u>2/6</u>
compaction	<u>0/3</u>
floodplain accessible	<u>9/9</u>

TOTAL: 30/57 = **53%**
