Stream Health Assessments

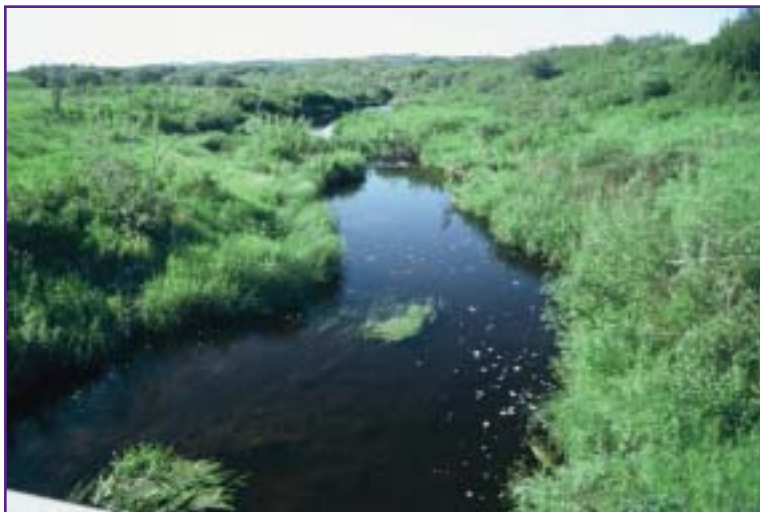
Score:

vegetation cover	<u>6/6</u>
invasive weeds	<u>0/6</u>
disturbance species	<u>0/3</u>
woody regeneration	<u>6/6</u>
wood utilization	<u>2/3</u>
dead wood	<u>3/3</u>
root mass / deep roots	<u>6/6</u>
bare ground	<u>6/6</u>
site alteration	<u>6/6</u>
compaction	<u>3/3</u>
floodplain accessible	<u>9/9</u>

TOTAL: 47/57 = **82%**

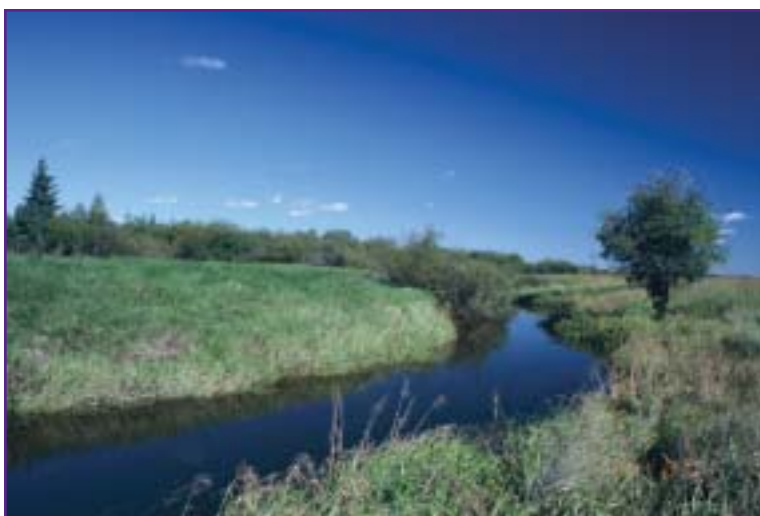
Score:

vegetation cover	<u>6/6</u>
invasive weeds	<u>0/6</u>
disturbance species	<u>1/3</u>
woody regeneration	<u>4/6</u>
wood utilization	<u>2/3</u>
dead wood	<u>3/3</u>
root mass / deep roots	<u>4/6</u>
bare ground	<u>4/6</u>
site alteration	<u>6/6</u>
compaction	<u>1/3</u>
floodplain accessible	<u>6/9</u>

TOTAL: 37/57 = **65%**

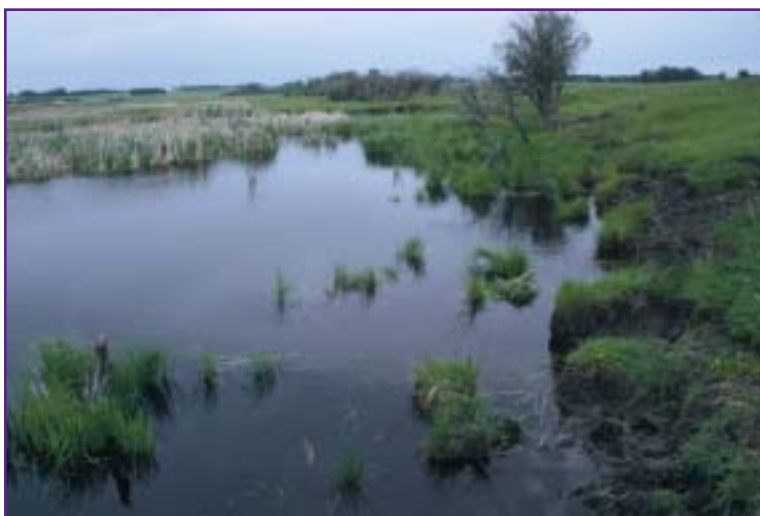
Score:

vegetation cover	<u>4/6</u>
invasive weeds	<u>4/6</u>
disturbance species	<u>1/3</u>
woody regeneration	<u>2/6</u>
wood utilization	<u>0/3</u>
dead wood	<u>2/3</u>
root mass / deep roots	<u>4/6</u>
bare ground	<u>2/6</u>
site alteration	<u>2/6</u>
compaction	<u>0/3</u>
floodplain accessible	<u>9/9</u>

TOTAL: 30/57 = **53%**
